Damage in the 2008 China Earthquake

Ari Wibowo¹, Bidur Kafle², Alireza Mohyeddin Kermani², Nelson T.K. Lam²,
John L. Wilson¹, Emad F. Gad^{1,2}

ABSTRACT:

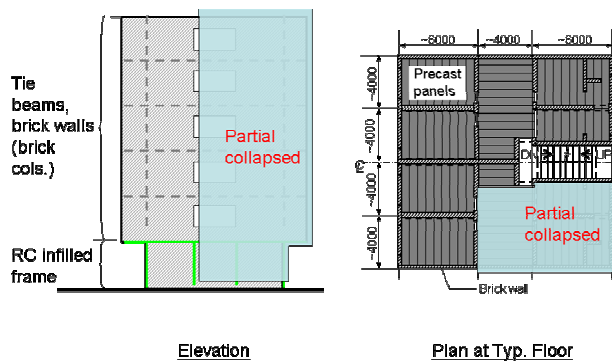
Damage appeared to be isolated to precast floor system which had not been properly connected to the vertical support elements, resulting in unseating of the slabs elements as shown in Figure 5 and 6. The slabs not only resist the gravity loads but provide overall structural stability through horizontal diaphragm action, hence failure of the slabs system will compromise the overall structural integrity of the building.

Figure 5. Schematic of precast slabs failure resulting in partial collapse of building

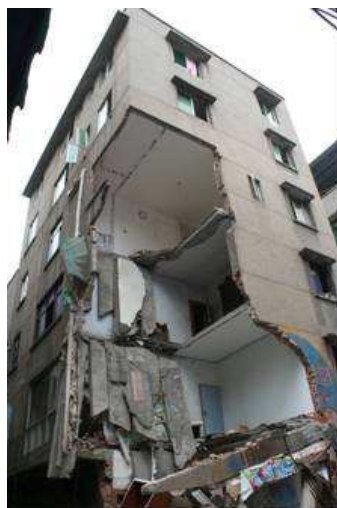
a) in Mianyang

Figure 6. Partial collapse of building with precast slabs floor

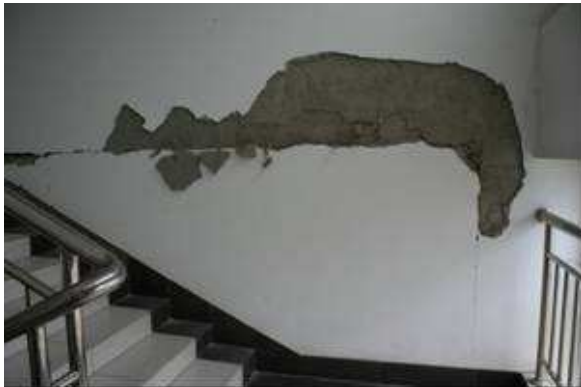
Within the cities of Chengdu and Mianyang, the main damage observed were the inplane cracking of infill walls as shown in Figure 7 and 8, the collapses of chimney and the sliding of unrestrained roof tiles as shown in Figure 9 and 10. The MMI scale explicitly reports chimney damage states with values of VI, VII and VIII associated with cracking, failure of weak chimney and widespread failure respectively.

Figure 7. Horizontal crack at the Sichuan University office in Chengdu.

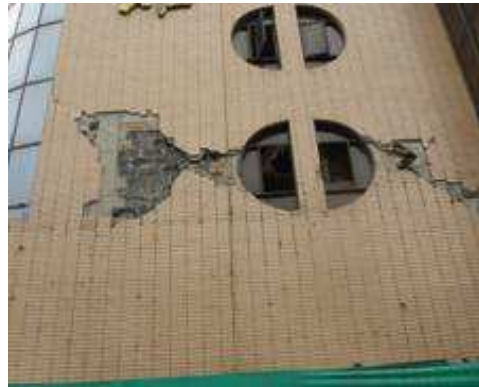
Figure 8. Diagonal shear crack of one of the buildings in Mianyang.

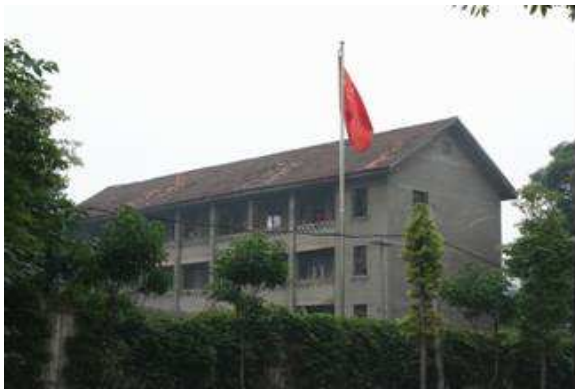
Figure 9. A building in Chengdu with roof tile sliding.

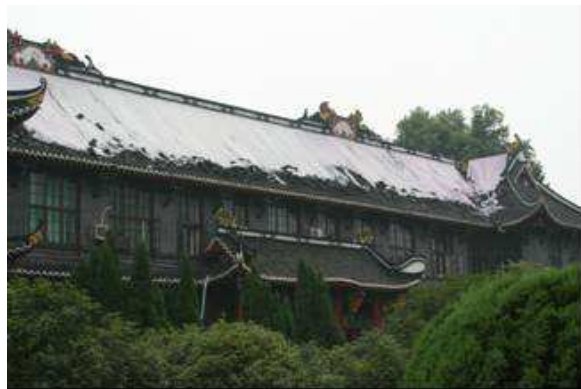
Figure 10. Many old buildings at Sichuan University in Chengdu suffered from roof tile damage.

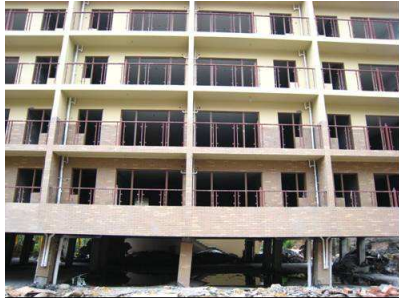
collapse. In the Chengdu and Mianyang region, no soft storey buildings were observed to have collapsed, whilst in Dujiangyan and Ying Xiu many buildings were significantly damaged with drifts up to 7.5% measured whilst other soft storey building collapsed as shown in Figure 11 to 16.

Figure 11. Soft first storey of 6-storeys building in Dujiangyan with drift about 7.5%

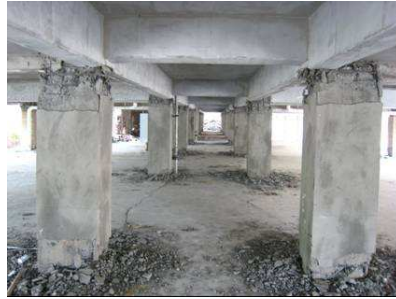
Figure 12. Plastic hinge failure at all first-storey columns of Figure 11.

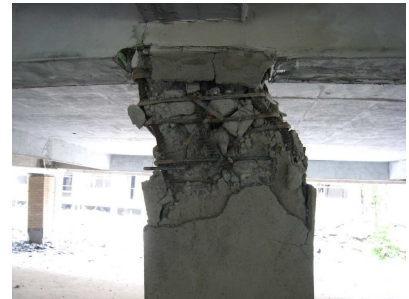
Figure 13. Formation of plastic hinges at both ends of the columns shown in Figure 12.

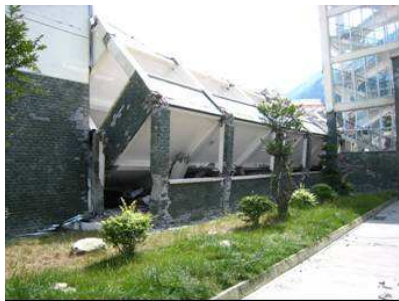
Figure 14. Building in Ying Xiu collapsed because of soft storey mechanism on one direction and short column on other directions.

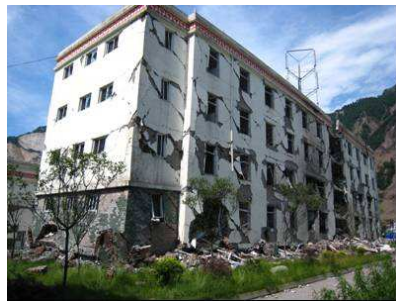
Figure 15. First storey of 5-storeys building in Ying Xiu has totally collapsed.

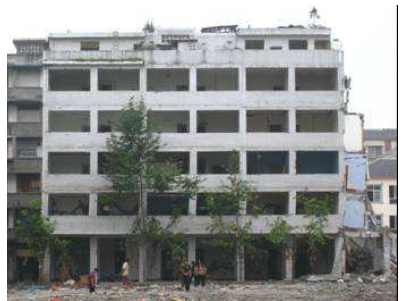
Figure 16. Soft storey damage of second storey with drift about 5.6% in Dujiangyan

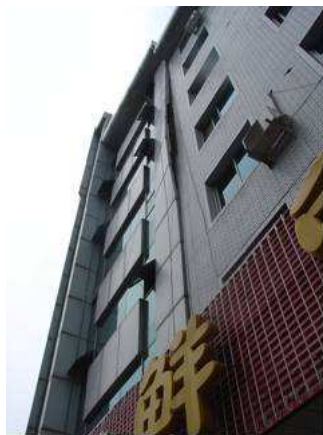
Figure 17. Façade element damage of building in Mianyang.

Some local inplane façade damage caused by excessive drift was observed at Qingyang district in Chengdu and in Mianyang as shown in Figure 17. Meanwhile for the higher intensity shaking in Dujiangyan and Ying Xiu the moderate façade damage was more widespread.

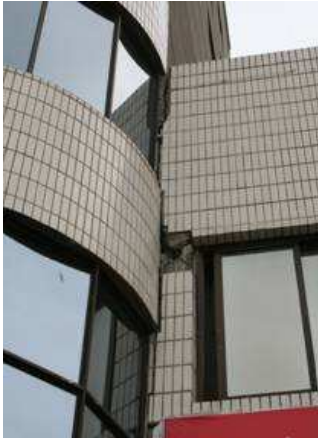
Figure 18. Column shear failure at one of building in Mianyang.

Many buildings in Sichuan had inadequate construction quality including insufficient reinforcement, poor detailing and poor quality concrete as shown in Figure 18 to 21. Some of the poor detailing included lack of reinforcement in the beam column joint, lack of transverse ties in the beam and column and lack of an embedment length for reinforcement anchorage. Closely spaced transverse reinforcement in the form of closed ties with 135° hooks provides concrete confinement, buckling restraint of longitudinal reinforcement and additional shear capacity, which improve the non linear performance.

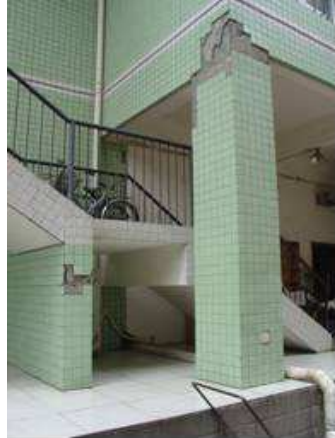
Figure 19. One of building in Mianyang suffered from beam-column joint failure

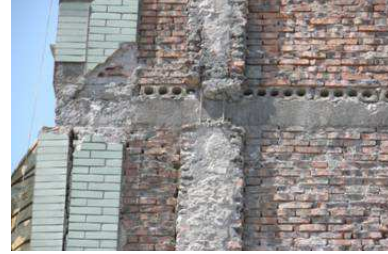
Figure 20. Poor beam-joint connection

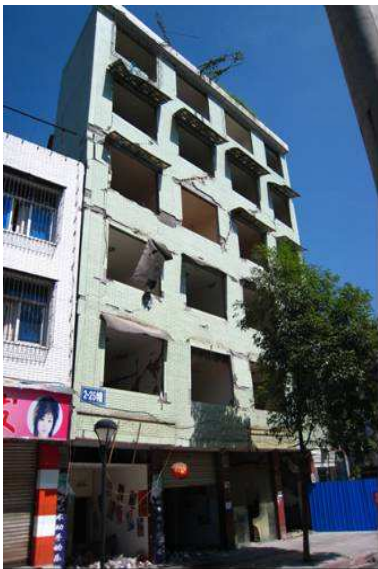
Figure 22. Pounding between two different building in Dujiangyan

In Chengdu, particularly in the market areas, many buildings greater than 3-storeys were located very close or adjacent to each other resulting in pounding and some damage. The more severe structural pounding damages were observed in Dujiangyan and Mianyang as shown in Figure 22. The typical pounding damage occurred in the investigated area are shown schematically in Figure 23 [3].
