A Tale of Two Earthquakes

Paul Grundy, Professor Emeritus
Department of Civil Engineering, Monash University
paul.grundy@eng.monash.edu.au

Abstract

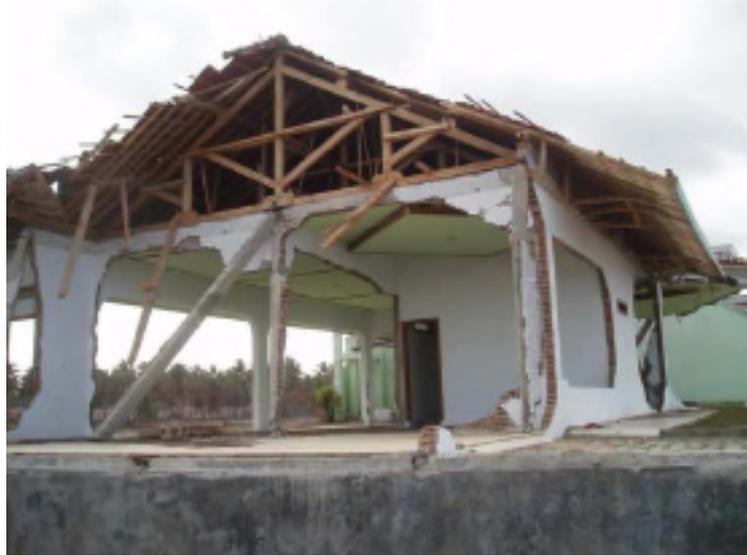
The columns of RC frames ranged from 100mm x 100mm with four 3mm diameter wires for reinforcement to 200mm x 200mm with four plain bars of 10mm or 12 mm diameter. The RC framed house shown in Figure 2 probably had the former type of column. The height of the tsunami was estimated to be 3.8m. The front has been demolished and the masonry walls punched out. The house shown in Figure 3

Figure 2: An RC framed building damaged by a 3.8m tsunami (Reeves et al, 2007)

Of course, the building shown in Figure 2 could have been struck by debris, the worst forms being floating cars or boats carried along at about 4-5 m/s for the given depth of water. In the absence of debris, rules have been developed for 'tsunami load' on inundated structures (Okada et al, 2005). The most significant is the lateral force due to run-up against the wall facing the oncoming tsunami. There are possibly impact and drag forces, but these are usually less. Run-up is assumed to be three times the height of the tsunami (Figure 4). The lateral pressure of the (stationary) fluid is hydrostatic. Buildings with transparency to water flow at ground level, or standing in isolation allowing flow around the building, will experience less run-up. A building properly design for seismic loading in Indonesia is likely to be adequate for tsunami loading.

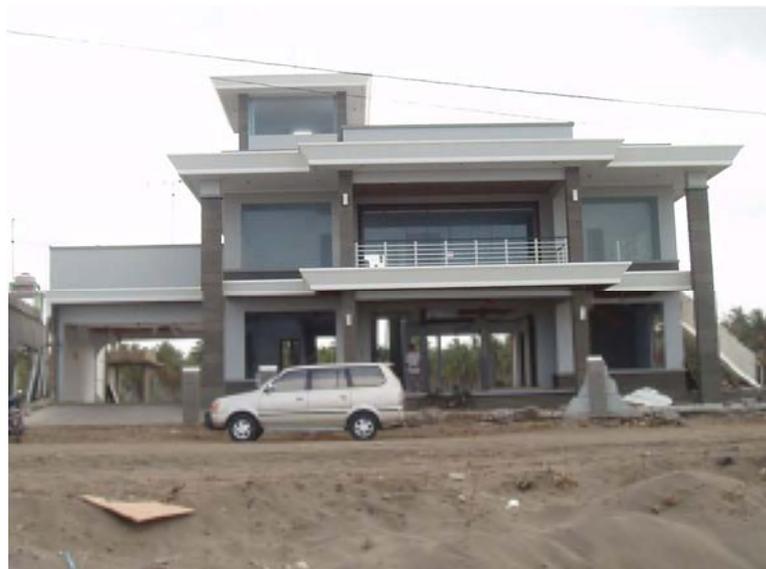
probably had more substantial columns and the damage from the tsunami of a similar height is superficial.

Figure 3: An RC framed building which survived a 3.8m tsunami with minor damage (Reeves et al, 2007)

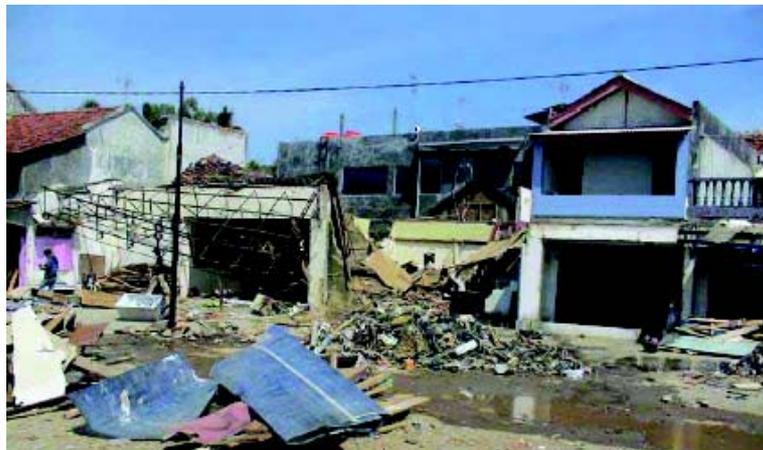
Figure 5: Damage at Pangandaran; elevation $\sim 2.5\text{m}$, tsunami height 3.3-5.4m

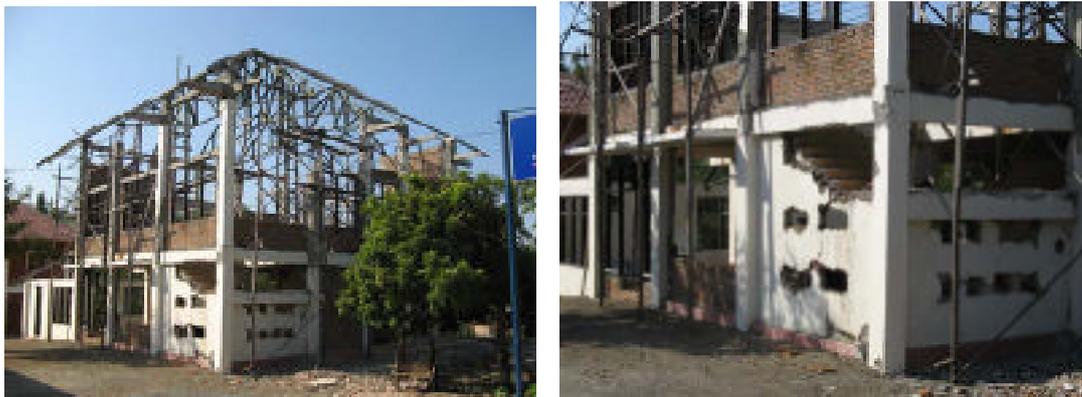
Figure 8 depicts a severely damaged commercial building under restoration. There is evidence of poor detailing at joints, and the infill masonry is being replaced.

Figure 8: A severely damaged engineered building under restoration

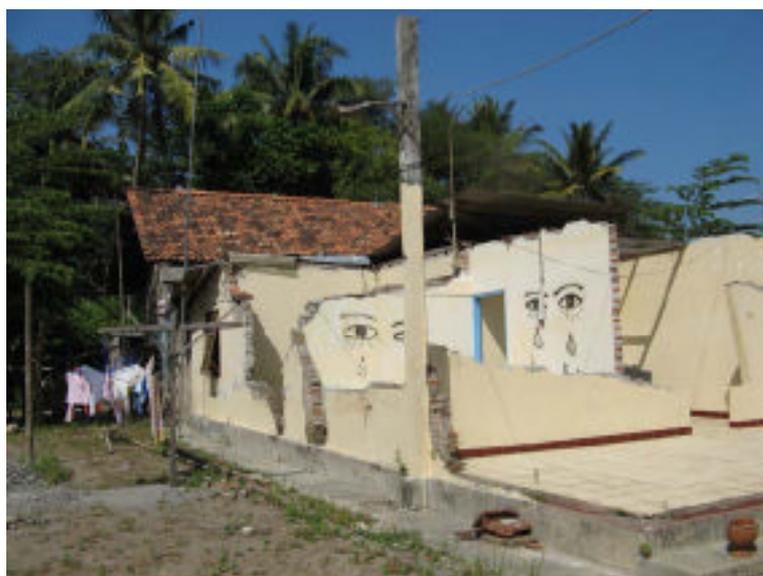
Figure 9 depicts the fate of many houses of traditional construction. The foundation consists of a ring beam of reinforced concrete not deeply bedded, with additional beams under interior walls. The ring beam is filled in with hand compacted rock and gravel to provide a floor level above the natural surface. The masonry walls usually have rather thin bricks with rather thick beds of lime mortar. They are plastered. Rafters and battens supporting roof tiles sit on the walls.

Figure 9: A house cleared of rubble awaiting reconstruction

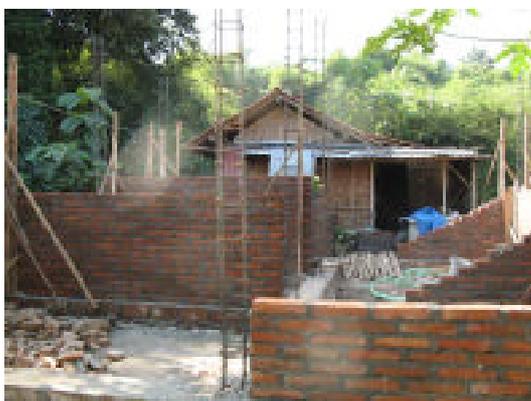
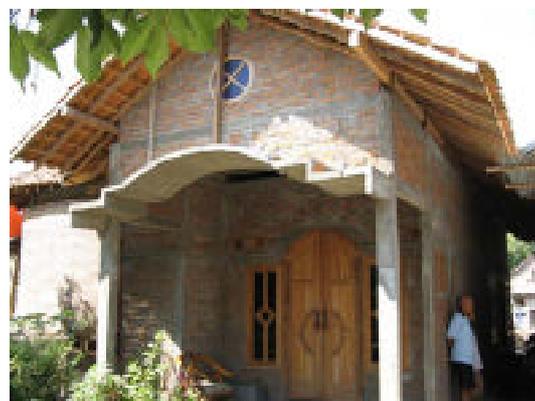
An even greater challenge than finding affordable earthquake resistant designs that could be built with minimal expertise imported from outside the community, was the achievement of adequate standards of construction. Figure 19 shows a house in preparation for reconstruction with RC framework; Figure 20 shows a completed brickwork and framing prior to rendering. However, Figures 21 and 22 show very poorly compacted concrete in the columns, which could largely undo the earthquake resistance of the structures.

Ideally, the concrete should be compacted with a mechanical vibrator. Such an item is too expensive for the individual house builder, but a community should be able to share or rent one, and to have a short training course in its proper use.

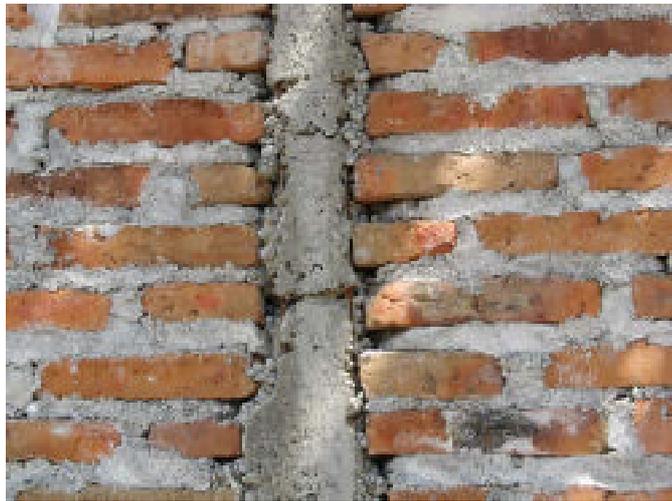
Figure 22: Rebar exposed in uncompactd column
