Development of Guidance Information for the Repair and Re-building of Houses Following the Canterbury Earthquake Series

Graeme J Beattie⁽¹⁾

1. Principal Structural Engineer, BRANZ Ltd, Private Bag 50908, Porirua 5240, New Zealand. Email: graeme.beattie@branz.co.nz

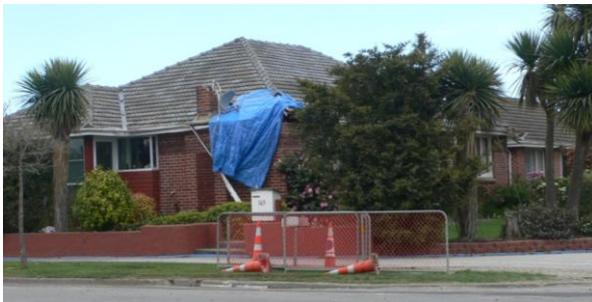
Figure 1 Collapsed unreinforced masonry chimney

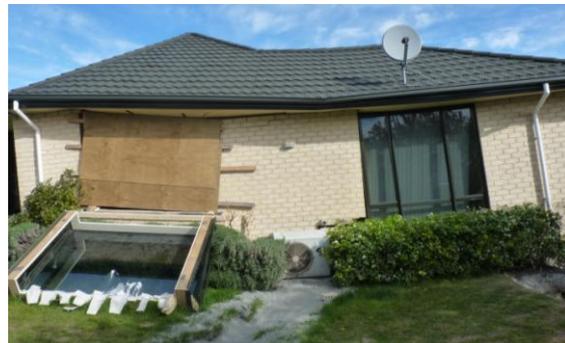
Figure 2 Liquefaction damage

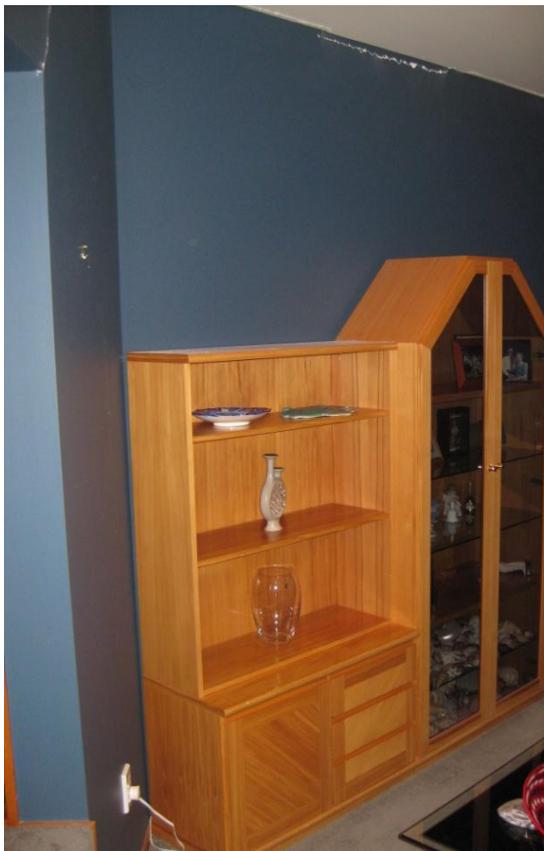
Sheet bracing materials also behaved well, providing stability to the houses while at the same time dissipating earthquake energy in a ductile fashion. In many houses, the visible damage to wall linings was minor (cracking of plasterboard joints - Figure 3(a)) while in others the damage was very significant (diagonal cracking through sheets and detached sheets - Figure 3(b)). In the second case, the repair solution is clear. The lining must be stripped off and replaced. The difficulty is in identifying the underlying damage in the first case and appropriately repairing the wall. In houses with minor damage throughout, the occupants have often commented that the house is “noisier” than it had been before the earthquakes. The reason for this is that in the earthquakes the fixings have moved small amounts in the lining, creating slots and under minor excitations from wind and aftershocks the house is able to flex more. There is no significant loss in strength because this is taken up once the fixings have reached the end of the slots.

(a) Minor cracking

Re-stopping the joints between sheets is not going to recover the dwelling stiffness. The EAG has therefore recommended that if the cracking is evident at the panel junctions and there is also evidence of movement at the skirting boards then the stopping should be scraped out and the panels re-fixed around the perimeter of the sheets. This has been shown by test to substantially regain the building stiffness.

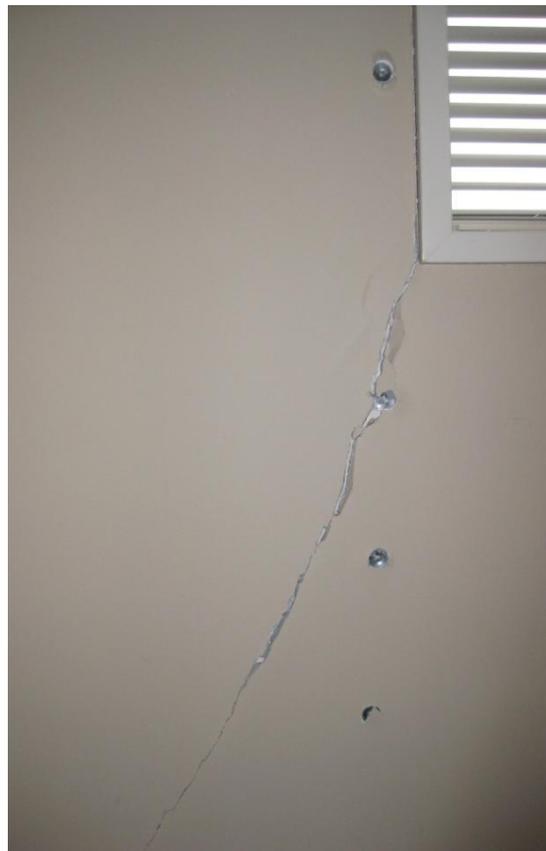
(b) major damage
