IMPACTS OF REMOTE LOW LEVEL SEISMIC EVENTS ON THE MONARO REGION NSW

Australian Earthquake Engineering Society Conference,
18-20 November 2011, Novotel Barossa Valley Resort, South Australia

Geoff Bowland

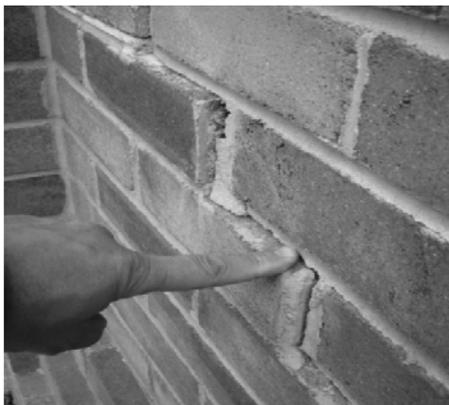
7mm displacement at Bombala Church Wall
Fig 1

seismic action has largely not been recognised by engineers as has been revealed in the Bombala church case.

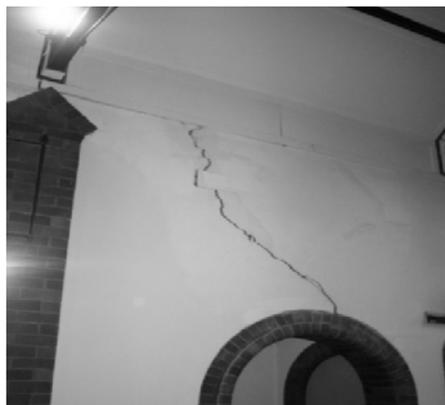
Even width crack in Bombala Church Wall
Fig 2

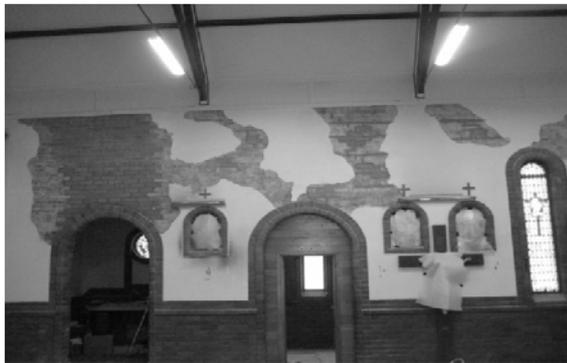
Fig 5

2010 1.9, epicentre near Snowy Airport at Cooma, extensive cracking occurred again in St Mary's church walls, concentrated in the same major locations as before with the damage being apparent in a SE-NW line through this EW facing church.

Some of the 2007 wall repairs to St Marys

recommended for the lodge in Thredbo would remove repeated hammer and anvil actions to the bathroom wall and mitigate the danger of a wall collapse from a larger event. If the roof tiles were to be removed from St Mary's roof and replaced with light weight materials there should be less reaction to a seismic event and less danger to occupants from heavy tiles falling on them. Procedures of what to do in an earthquake should be permanently on display in the church and other susceptible buildings. Engineers in general should be made aware of the particular nature of seismic cracking patterns and seismologists should be careful not to play down the potential effects of minor seismic events. To coin a phrase from the RSL:-

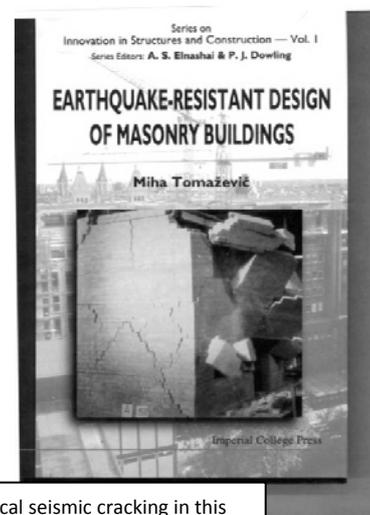
Fig 7

Note the typical seismic cracking in this university test
