Earthquake Damage Characteristics and Assessment of Lifeline Systems on May 12th, 2008, Sichuan Earthquake

Aiping Tang^{1,2}, Lianfa Wang² and Guidong Zou³

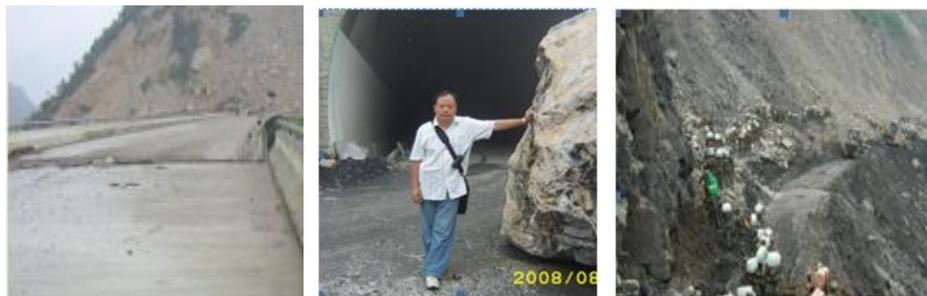
(a) Tunnel entrance is covered by rock landslide (b, c) traffic is blocked by falling rocks

According to site investigation, 90 percent of traffic interruption in meizoseismal area was attributed to landslide, debris, falling rock and uneven foundation subsidence and ground rupture. Four highways to Yingxiu town are completely interrupted due to heavy landslides and debris. In Hongkou and Xiaoyudong, several bridges were damaged duo to large ground displacement or deformation related to fault motions. A railway system for coal transportation was found to be damaged due to foundation slope failure (Fig. 2, e, f).

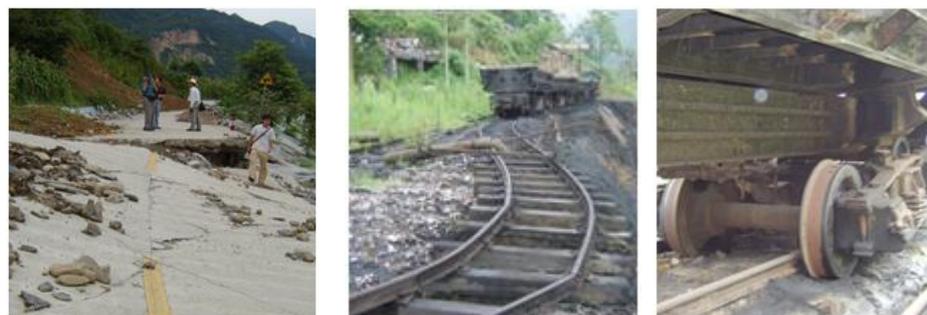
Fig.2. geotechnical disasters and transportation system

d) Failure of highway foundation (e) damaged railing track (f) carriage off the track

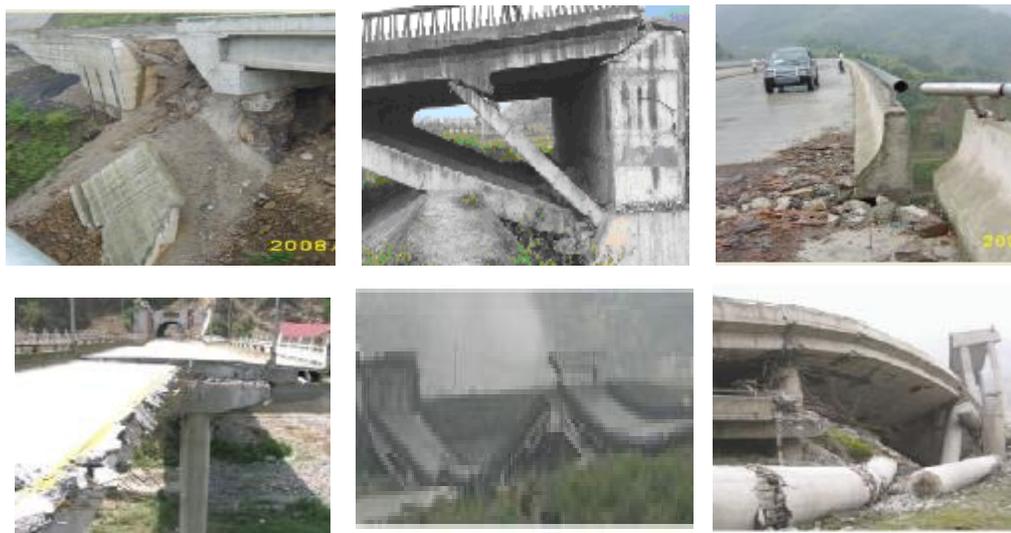
Fig.3. typical earthquake damaged bridges [7]

Although most of bridge subsystem are intact or slight damaged, but some important bridges are also severely damaged in this earthquake because they were not adequately designed for earthquakes, resulting in the loss of many river crossings. (Table 1, 2), which made the emergency rescuing very difficult. The fault and near-fault strong motion, and geotechnical disaster triggered by fault motion were three of the important factors. The typical damaged bridges in details are shown in Fig.3.

a) Jianjianghe Bridge

b) Xiaoyudong Bridge

c) Baihua Bridge

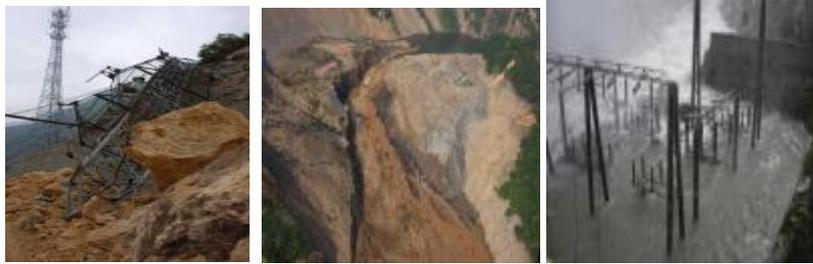
Power systems were damaged due to pulse velocity near fault, landslide and rock collapse. In Yinxiu town, a hydro-power station was buried by debris. There were many high-volt electric poles installed in slope to tilt down because of slope failures of foundations (Fig. 4, a). There are 470 hydropower stations to be affected in this earthquake, and parts of them completely lost their functions because of landslide and debris to be full of the entire reservoirs' volumes or split and subsidence of dams (Fig. 4 b). Some Power transmission equipments were inundated and dam was overtopped because of barrier lakes formed by landslides, landslide or collapse (Fig. 4 c).

(a) electric-pole tilt down (b) reservoirs filled by landslides (c) inundated power equipments
 Fig.4. Power supply system typical earthquake damage

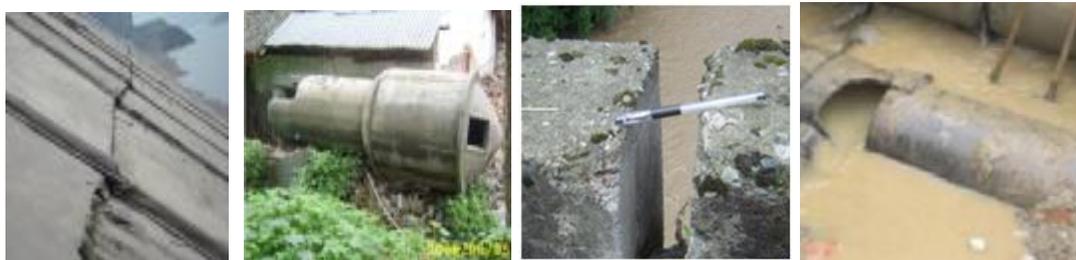
Fig.5. damaged water supply system

The Chinese Earthquake Administration estimated that 18,000 miles of buried water pipelines were subjected to reasonably strong ground motions due to the PGA 0.10g or higher. About 14,000 miles of pipelines had restored water service after 20 days of the main earthquake. The out of service and extensive damage to buried pipes was mostly due to landslide, strong ground shaking, differential movement at bridge abutments, fault, housing collapse, lack of manpower and parts to perform repairs, and water treatment plants out of service due to structural damage and water pollution.

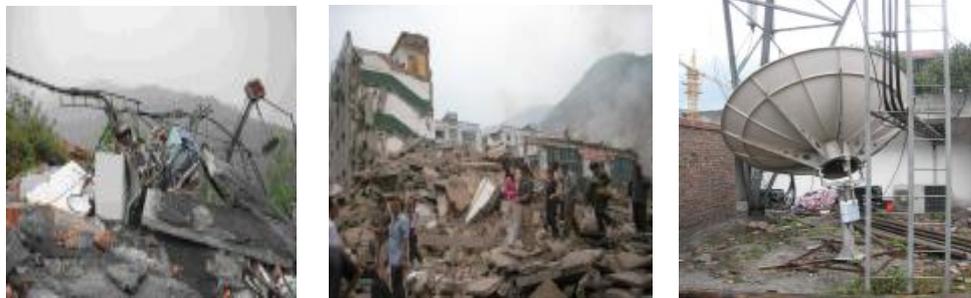
Fig.6. damaged telecommunication system (About 2300 mobile stations were damaged)

The telecommunication system was also damaged. In Sichuan, Gansu and Shanxi provinces, there were 3,897 telecommunication offices, 29,064 cell phone stations and 28765 km long line to be damaged. There were 142,078 telecommunication poles broken or collapsed due strong earthquake motion, landslide and debris. Telecommunication building, equips and apparatus was found to be damaged by falling rock and landslide in Yingxiu town (Fig.6). The backup systems for emergency response were buried by landslide, debris and collapsed building. The

(a, b) Damaged unreinforced masonry and equipments (c) Satellite dish under the tower [C, 7]

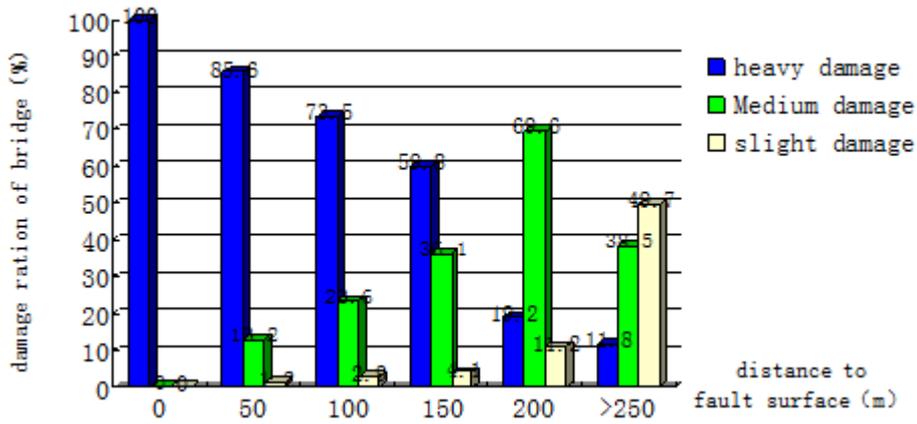
Based on the site investigation, typical damage characteristics to bridge were span collapsing, sliding between bearing and girder, shear key failure, damage of expansion joint, pounding of adjacent girders, and tilting and cracking of abutments. Almost all of the medium and severely damaged were near fault, where there are strong ground motion recorders. Table 3 illustrates two typical examples. It is obvious that the nearer the bridge located to the fault, the severer the bridge was damaged. This damage phenomenon is particularly obvious within 10 m in both side of fault. According to statistics of lifeline earthquake damage, this safety distance to the fault

Fig. 7 the relationship of bridge damage to distance

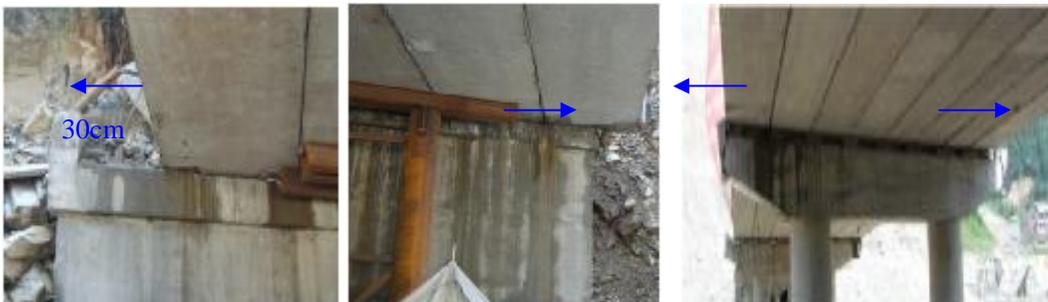
There were same damaged phenomena in all of the damaged bridges near fault: 1) the girder rotated in horizon, so, the protection to anti-falling of deck was damaged. The rotation direction was clockwise, in accordance with the fault rupture direction ((Fig.8, right-lateral strike fault). 2) The girder took place the snake-deformation in horizontal direction and waving of deck in vertical direction, which meant wave propagation effect (Fig.9 a). 3) Obvious pressure deformation in axial direction of these bridges, which meant pulse-like motion which exposed the structure to high input energy (Fig.9, b, c).

Fig. 8. Mingjiang Bridge in Yingxiu town (clockwise rotation)

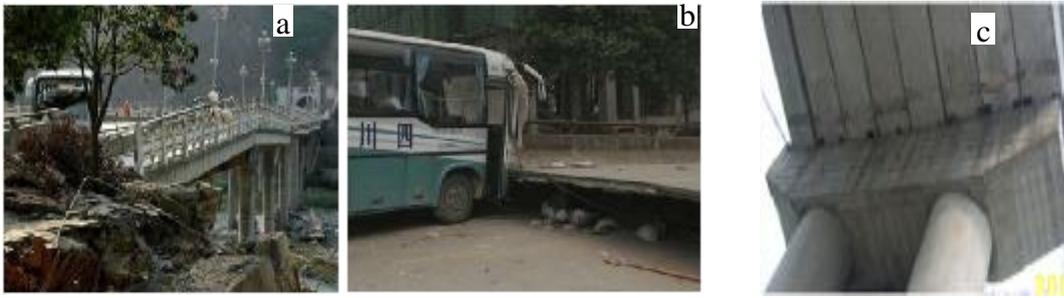
Fig.9. Jianjianhe bridge in Beichuan City(a,b) and Gaoyuan bridge in Hongkou town (c)
