# Earthquake damage in wastewater systems and post-earthquake repair methods; limitation and practice

M. R. Zare<sup>1</sup>, S. Wilkinson<sup>2</sup>, R. Potangaroa<sup>3</sup>

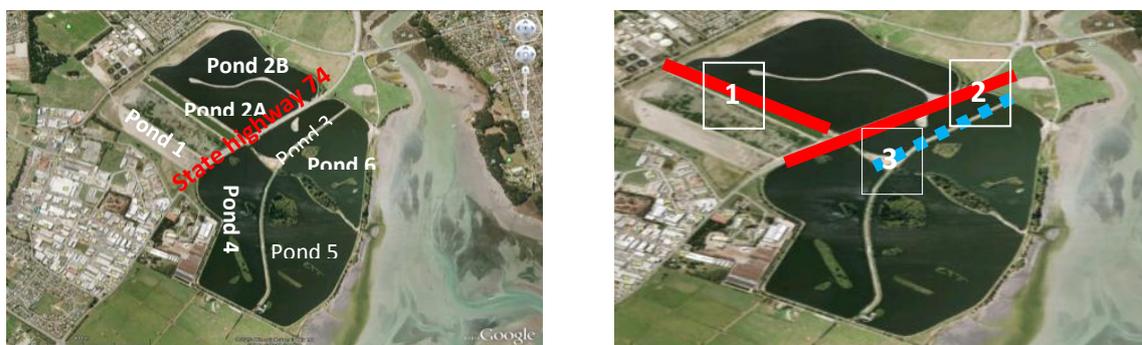
Figure 1: Christchurch wastewater treatment plant ponds location and damage (Google map)

Significant earthquake induced damage in the Bromley WWTP can be divided into damage to the ponds, connection pipelines and pipeline inside the pond area. The 2010 earthquake significantly affected the pipes installed within the pond area; especially the connecting pipes between Ponds 2 and 3, and also the bypass pipeline in Pond 1. The earthquake severely

damaged the under-road 900 mm concrete pipes which connect the treatment ponds on both sides of the State Highway between Pond 2 and Pond 3. Joint separations and pipe crushing in joints and body were the main types of damage in the pipes underneath of State highway 74. The pipes failure created some significant sink holes in the main road and forced Highway 74 to be closed for two weeks. Failure of the bypass pipeline is another significant pipe failure in the pond area. The joint separation and misalignment (horizontally and vertically) were the main types of failure in the concrete bypass pipes.

Further significant damage caused by the 2010 earthquake to the Christchurch WWTP was pond damage. After the earthquake, some stop banks slumped to the ponds or outside the ponds, and caused severe cracks in some particular regions including State Highway 74, stop bank between the ponds 3 and 6, stop bank shared by the ponds 4 and 5 and stop bank between the Pond 1 and 2. The earthquake induced damage between Ponds 3 and 6 and also damage in ponds 4 and 5 were serious because of the significant difference in water levels in both sides of the shared stop banks. The right photo in Figure 1 shows the main damaged regions (lines 1 and 2) and also installed sheet piles which were installed to protect the severely damaged stop bank (line 3). After the earthquake, in order to decrease risk of dike failure and also protect of the downstream ponds, first, the water level in the Ponds 3 and 4 was decreased, and then two series of sheet piles of 250 and 170 meter in length were installed in the shared dikes 3-6 and 4-5, respectively. Some minor cracks were also seen near the recently constructed pumping stations underneath Pond 6 and also stop banks of Pond 2. On top of the direct damage in the ponds, power outage after the 2010 Darfield earthquake affected the wastewater treatment plant. For instance, on the second day after the earthquake, the Christchurch WWTP came to service again (Gordon 2010).

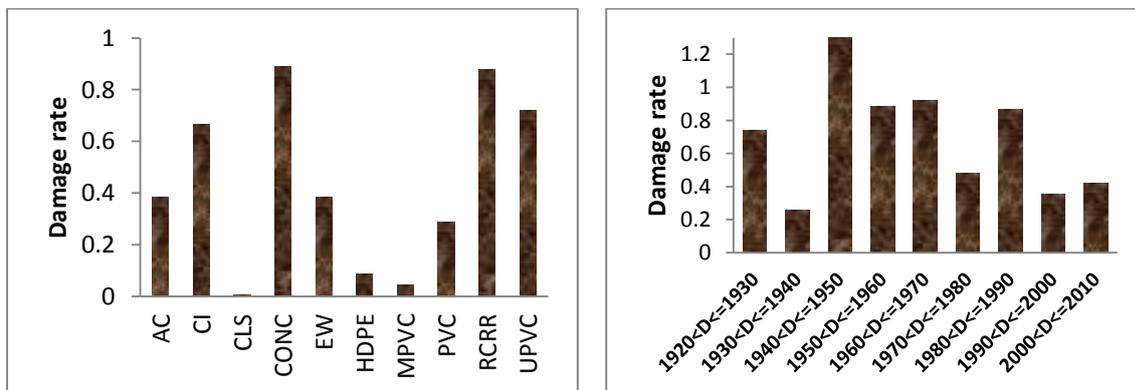
joint (RCRR), the unplasticized poly vinyl chloride (UPVC), the earthen ware (EW), the concrete (CONC) and the asbestos (AC) pipes shown in the left graph on Figure 2. Damage rate is defined as number of defects in unit length of pipelines. The GIS data base of the damaged wastewater reticulation is used to calculate damage rate. Damage rate in each type of pipes is calculated by total length of each type of pipes in terms of material, diameters, pipe age and etc. divided by number of defects in that particular type of pipe. Damage rates in concrete and reinforced concrete pipes are significant and the damage rate is approximately about 0.9 per unit length of each type of pipe. High damage rate in concrete pipes shows the pipes were probably affected by corrosion in the Christchurch wastewater reticulation. If the damage rate in each pipe diameter is observed, the 150 and 225mm diameter pipes show the highest damage rate in the Christchurch wastewater reticulation with damage rates of 1.3 and 0.42, respectively.

Figure 2: Distribution of damage in the Christchurch WW network
