Performance Study of Seismic Bracing Assemblies of Suspended Ceiling Systems

G.C. Yao & W.C. Chen

Department of Architecture, National Cheng Kung University, Taiwan.

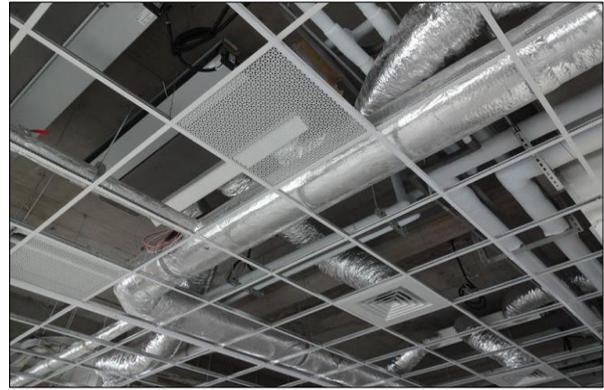
Figure 2. Unfavorable installation condition

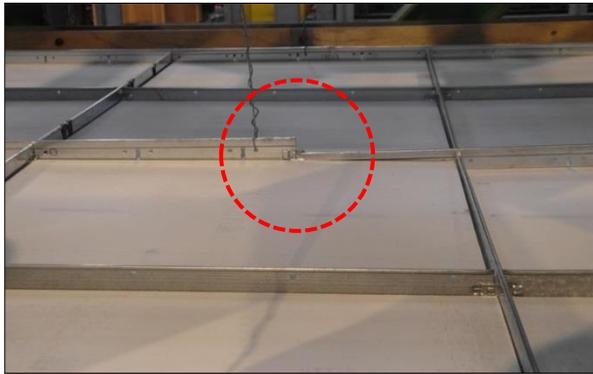
Figure 8. Detachment of the main runner joint Figure 9. Installation of the additional hanger wire

Table 1 summarizes the ceiling configurations. The ceiling specimens are divided into three groups in accordance with the installation of the bracing assemblies while all other details are identical. One thing is particularly worth mentioning, a certain connection joint of the main runner in the A type detached (Figure 8) every time when excited by vertical excitations, and this unexpected failure happened not only in one specimen. Therefore, an additional hanger wire shown in Figure 9 (denoted as “Connection joint reinforced” in Table 1) was installed when the specimen was reconstructed. The reason of this problem will be further discussed in the following section.

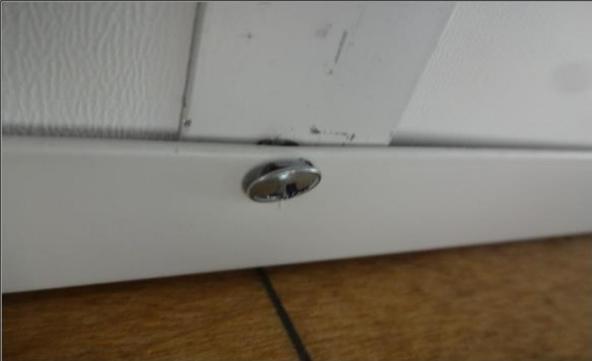
Almost no damage to the ceiling specimens was observed in response to unidirectional ground excitations while only a few tapping screws were dislodged as shown in Figure 10. The result revealed that the seismic ceiling systems used in Taiwan certainly had good resistance to horizontal forces. Concerning the experiments with vertical excitations, some of the perimeter connections and cross tee latches failed but the grid members especially the main runners always remained intact. Without losing the support of the tee grids, the tiles were not observed fallen over the course of the experiments. The largest damage was generated in C6 specimen that the ceiling was completely collapsed (Figure 11). Some of the failure patterns will be discussed in the following text.

The horizontal inertial force generated by the mass and the response acceleration of the ceiling induces axial force in the grid members. This force accumulates and becomes greater near the perimeter support than in the middle and is transferred to connection of tapping screws. However, as the tapping screws are installed regardless of the ceiling mass or the intensity of the input excitation, damage to tapping screws is always the first failure pattern observed during the experiments.

Figure 10. Dislodged tapping screw

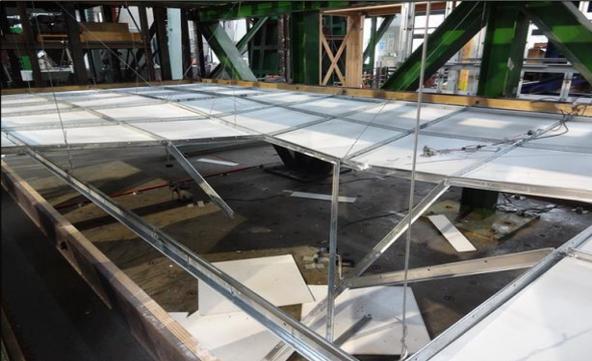
Figure 11. Collapse of the ceiling system

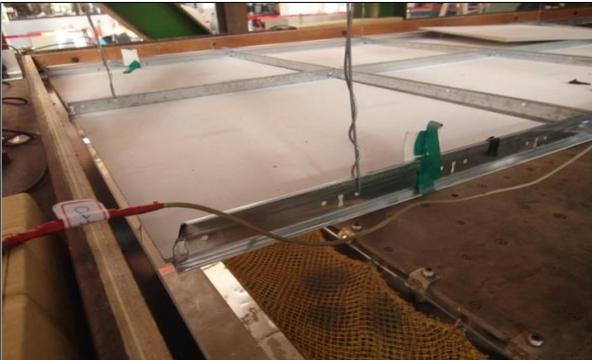
The primary damage in perimeter connections is the unseating of the ceiling grids from the wall molding as shown in Figure 12. Since 50mm wall molding is barely used in Taiwan therefore only 24mm wall molding was applied in the experiments. This failure can possibly due to the insufficient seat length of the wall molding at the unfixed sides or the failure of pop rivet at the fixed sides. As the unseating grid members move back toward the perimeter boundary, the grids hit the wall molding to cause the observed damage (Figure13). In some cases the failure of perimeter connection result in grid members and tiles falling from the ceiling, which particularly occurred around the connections of cross tees and wall moldings. In this paper, an additional test (B type configuration) without the wall moldings was conducted to evaluate the performance of the ceiling in a severe condition. The grid members of the ceiling were still intact in the shape of rectangle after the test and no falling tiles were observed (Figure 14). The result demonstrates the edge hanger wires can effectively prevent the grid members and tiles from falling.

Figure 12. Unseating of grid members

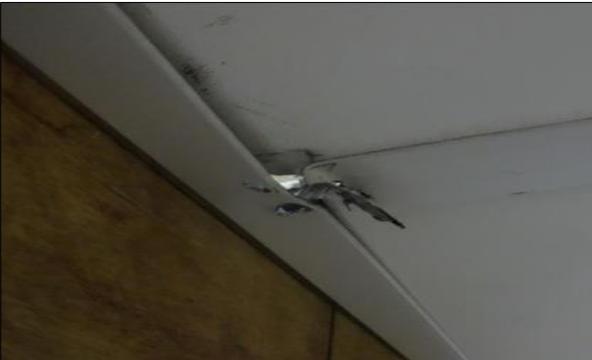
Figure 13. Failure of perimeter connection

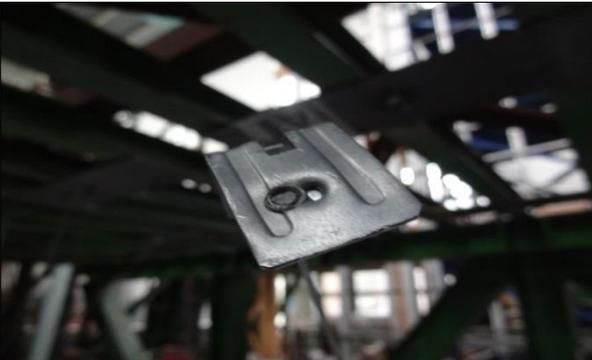
The attachment connecting the hanger wire and the frame structure failed during extreme vertical excitation (Figure 15). The failure of one hanger wire resulted in missing vertical supporting and uneven loading distribution of the ceiling grids, which led to a progressive failure of other hanger wires and caused a chaotic global collapse of the ceiling system. In all experiments, failure of hanger

wires only occurred in the braced ceiling specimen C6. In order to study whether the failure of hanger wire was caused by construction problem, the specimen C5 was reused with vertical ground motions after the unidirectional excitation test was finished. The result showed similar damage patterns including failure of hanger wires and serious collapse of the ceiling.

Figure 15. Failure of hanger wire

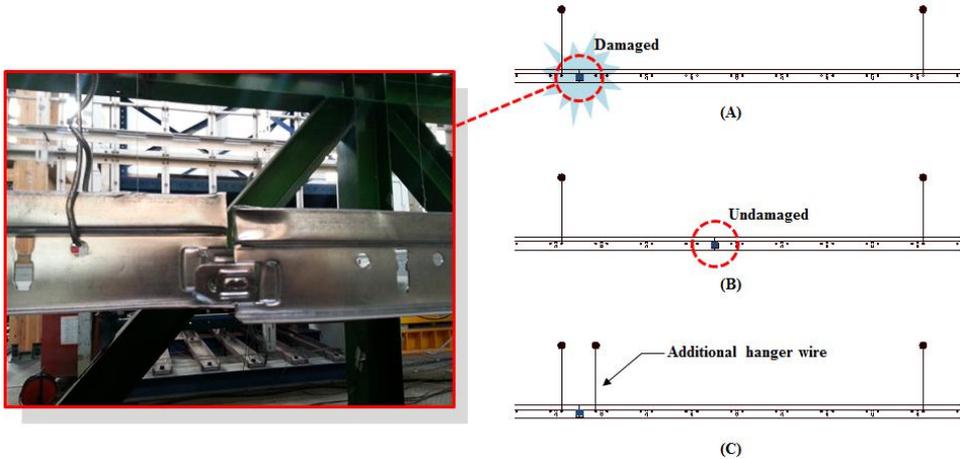
The damage to the connection joint of the main runner is an unexpected failure during experiments. The 7.3m main runner of the A type consisting of three pieces of grid members and has two connection joints along the grids, one of the joints shown in Figure 16-a failed frequently at low amplitude vertical excitation. Studying the locations of these two connection joints, the damaged joint is placed closely beside a hanger wire while the undamaged one is placed at the middle of two hanger wires (Figure 16-b). Displacement incompatibility on both sides of the connection joint is considered the most possible reason of the failure condition. When the grid members sustain downward loading inclusive of the excitation and the impact force from tiles, the grid on the left side of the joint is directly restrained by the hanger wire but the grid on the right side vibrates obviously. To prevent the displacement incompatibility between the connection joints, an additional hanger wire is installed

Figure 16. Damage to the connection joint of the main runner

beside the joint as shown in Figure 16-c, which has proven effective since no failure is observed after reinforcing.
