Tsunami Effects along the Western Australian coastline

By Brian Gaull of *Guria Consulting*; PO Box A122 Australind, W.A. 6233

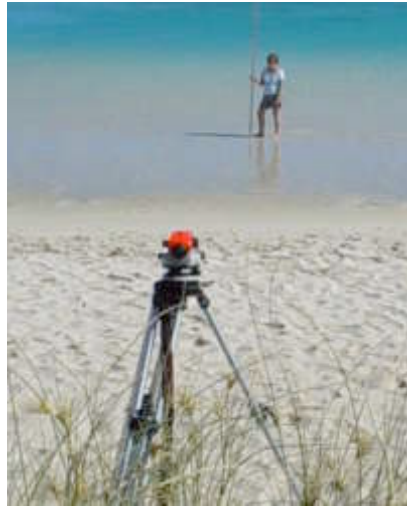
A digital photograph was taken at each levelling observation site. For consistency this photograph was taken from behind the levelling instrument showing the setup of the instrument on the tripod, the staff at the water’s edge and the surroundings, as seen in the example below.

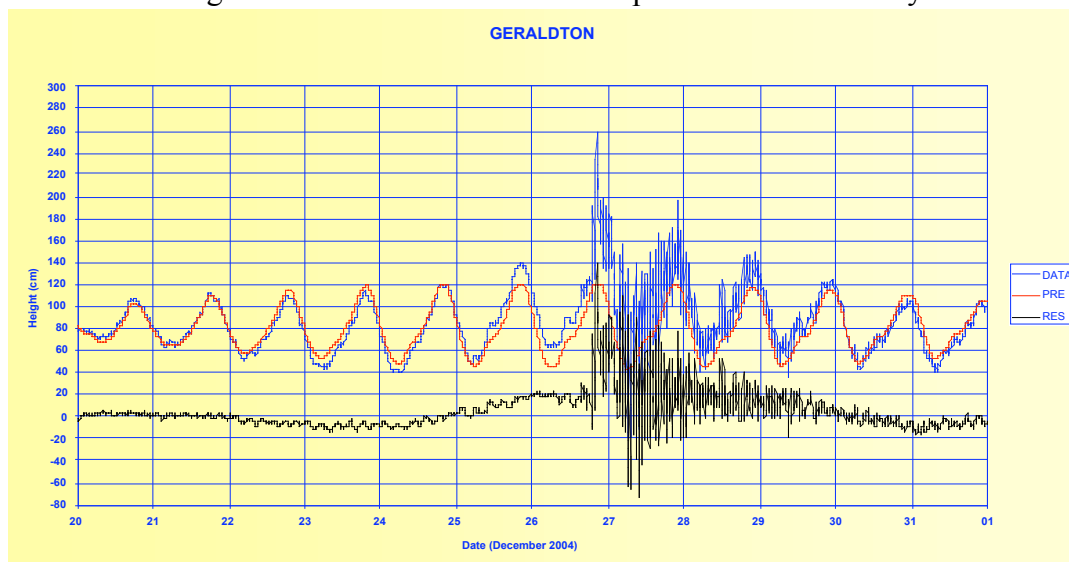
- 1) Tidal movements were visibly disturbed for several days at most gauges;
- 2) No significant effects could be seen at Wyndham and Broome;
- 3) Residual tidal effects from Pt Hedland to Carnarvon were of the order of half a metre, the smallest amplitudes seen were at Exmouth Gulf.
- 4) Geraldton was the standout with residual tidal amplitudes up to one and a half metres registered. This together with a peak tide in the evening of the 26/12/04 gave rise to a water level 0.6 metre greater than had hitherto been recorded. It was suggested by Matt Eliot (personal communication, 2005) that entrapment and resonance between the Abrolhos and the Central Coast of W.A. may have been the cause of these exceptional wave amplitudes. The full DPI chart data including the residual tidal data has been presented immediately below.

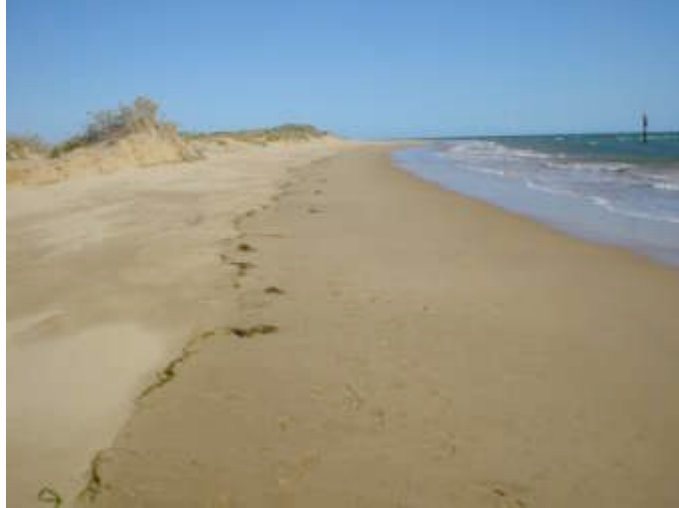
- 1) Credible anecdotal evidence suggests that the water from the tsunami crossed the isthmus at Pelican Point beach near Carnarvon (see photo below).

For this to take place, minimum water heights estimated were between 2.66 and 2.89 metres above MSL. This compares with a runup on the other side of the isthmus of the order of 0.5m, which is consistent with the tide gauge observations. It is thought that because the coastline at Pelican Point is unprotected and the sand spit (See marker on RHS of photograph above) may have directed the water towards the beach and in so doing the surge height was amplified.

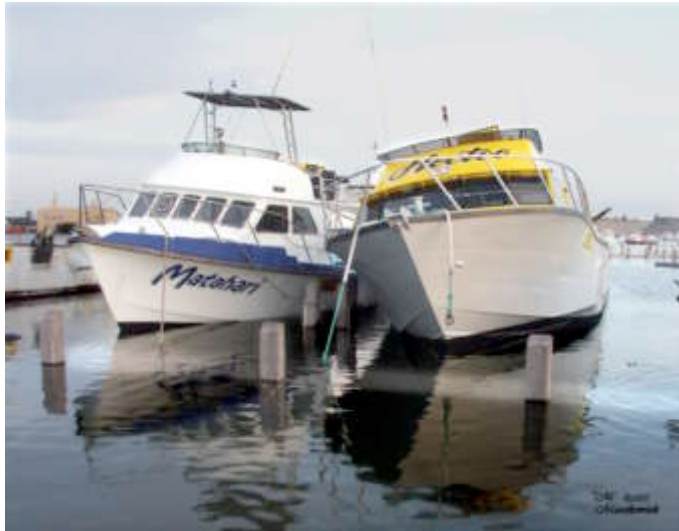
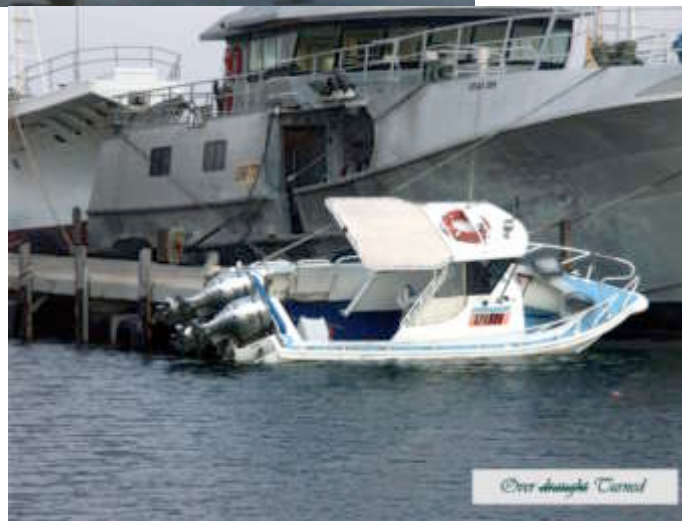
- 4) Anecdotal and photographic evidence showed that the (preliminary) corrected runup estimates at various places in Geraldton varied between about 1.0-2.0 metres. Considerable damage was incurred at the "Fisherman's wharf"; eg water inundated the local "fish-n-chip" shop to a reported 0.8 m and caused havoc for the boats tied to the wharf (see photographs on the next page).

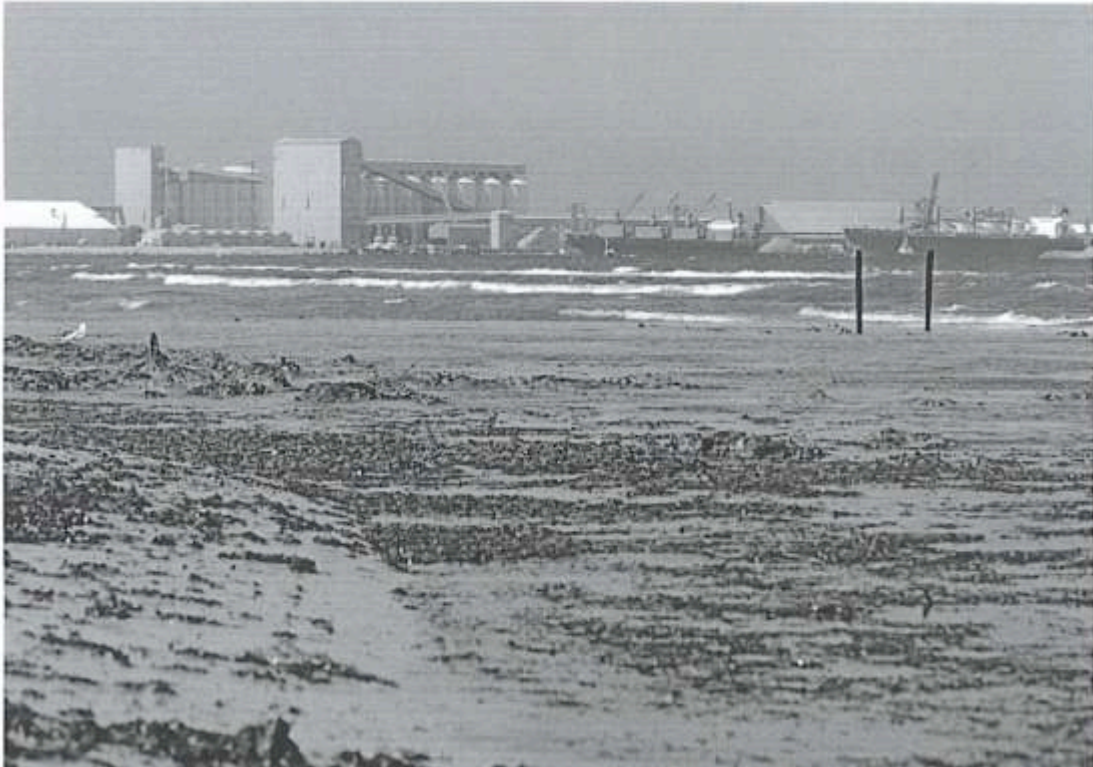
- 5) The newspaper photograph following the boat photos mentioned in point 4) above, was taken looking towards the main wharf in Geraldton and depicts perhaps the lowest tide experienced during the tsunami. On the 27/12/04 the tide receded to equal Geraldton's historical low tide (DPI staff, Fremantle).

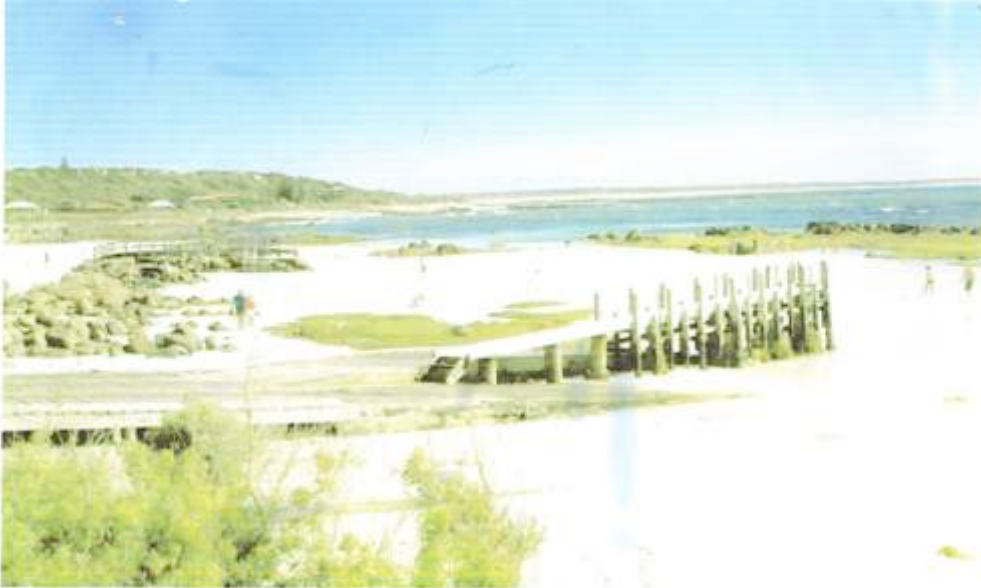
FLINDERS BAY — BOXING DAY 2004

- 10) The Flinders Bay boat ramp and jetty was left high and dry (see photo below), showing that extremes of tide were common along the west coast of Australia.
