In-situ lateral load test performance of Christchurch houses

H.W. Morris, & S. Beskhyroun

ABSTRACT:

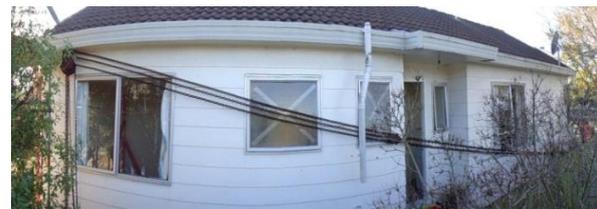
Figure 2: Panoramic view of 1983 House (13m x 6.2m) showing the chain block load system.

The initial test methodology was to load the house from a beam at the end of the house propped on a pivot to avoid vertically loading the walls. Two 7.5T chain blocks running diagonally along each side of the nearly rectangular houses were loaded up to 65kN to provide total uni-directional loading of 130kN (see Figures 1 and 2.) Load was applied in steps, including unloading at some stages. Damage was reviewed and recorded during pauses between load increases. The load reaction was applied from the top of the foundation for both houses tested in 2012. Both the 1983 and 1947 houses used a similar loading system, but the reaction points for the 1947 house were part way along the foundation.

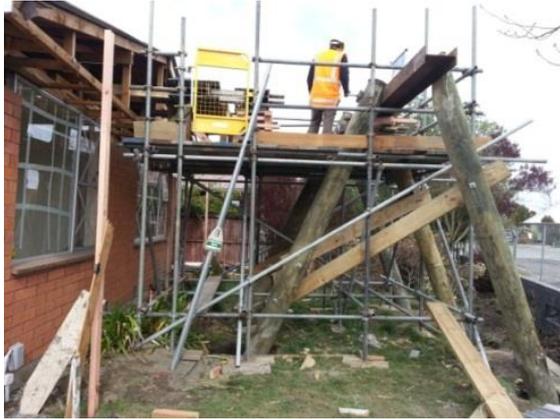
Figure 3: 1970's House test rig reaction frame with timber piles and steel beam.

The second 2013 test series objective was to measure full-house deflections and evaluate damage under reversing loads. In addition, snap-back tests allowed for the determination of fundamental frequencies of the 1923 and 1970 test houses so the dynamic responses could be correlated more accurately with building standards. The test procedure used a timber fitch beam with double steel inserts that could be added into the ceiling of a house without adding too much mass and thus altering the dynamic response. Loads were applied via a beam across the middle of the houses so compression closing deformations at the member junctions were not accumulated. A hydraulic load system was used to apply load to the houses including the house foundations. The reaction rig used for the 1970's house included 8m timber piles raked and driven to 5m depths with a steel universal beam connecting the pile tops (Figure 3) but was less stiff than the house. The rigidity of the load system was significantly increased for the 1923 house, where two substantial reinforced concrete foundation beams were fixed to the driven timber piles and a steel reaction frame was added. Figure 4, shows Laminated Veneer Lumber (LVL) load props being manually installed into the end of the house.

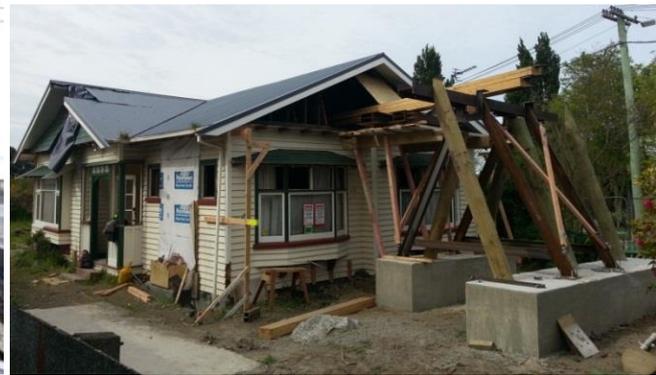
Figure 4: 1923 House with load props being installed. A concrete foundation and steel reaction frame were used in addition to the raking timber piles.

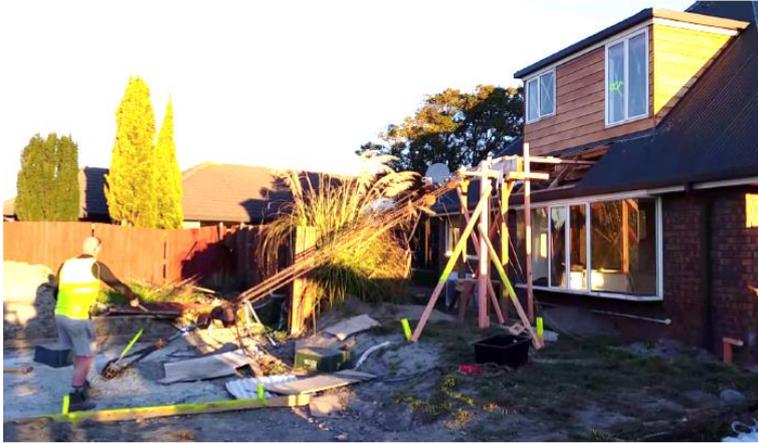
Figure 7: Reaction anchor, screw piled and embedded in ground beam, load cells and chain blocks, snap release ready to action 1993 house.

The rigidity of the 2014 load system was increased for the final uni-directional 1993 house test where a reinforced concrete foundation beam and slab were fixed to six screw piles, as shown in Figure 7. Two 7.5T chain blocks were fastened to the foundation block and to lengths of Reidbar. The Reidbars ran the length of the house and were fastened along their length to 190x45mm timber members. This was then fastened to 20mm thick plywood sheets and attached to the floor at regular intervals to ensure the load distribution was as even as possible. A support frame was constructed (Fig. 8) to aid the conversion of the tensile force in the chain blocks to horizontal forces running through the Reidbars and transfer vertical forces into the frame. Load was applied to the house in increments up to a maximum of 144 kN. Between each step, new damage to the house was observed and recorded. Five snap-back tests were completed in increasing loads, the highest being 80kN.

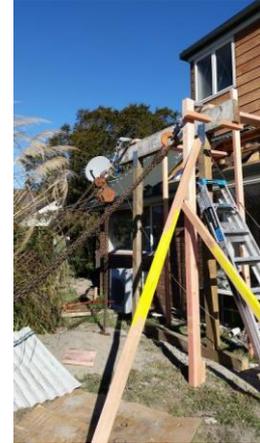
Figure 8: Detail of vertical Props and top chain block

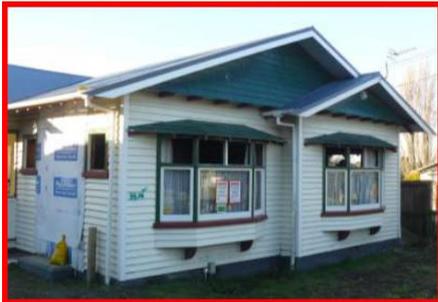
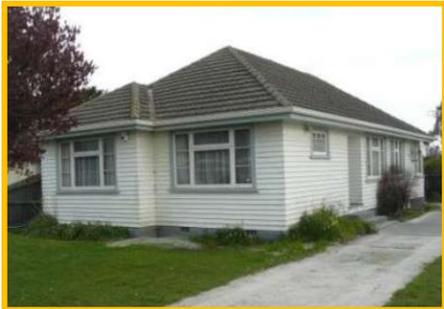
Table 1a. Houses tested, descriptions and key results

1923 - RETREAT ROAD	1947 - BEXLEY ROAD
1 Cladding	Weatherboard	Weatherboard
2 Lining	Plaster on lath	Fibrous plaster & light timber panelling
3 Floor	Suspended floorboards on piles	Suspended floorboards on piles
4 Foundation	Small upstand on concrete perimeter foundation	Concrete perimeter foundation
5 Year & Test	2013 Hydraulic cyclic & snap-back	2012 - Diagonal uni - directional
6 Photo

8 Built	1923	1947
9 Stiffness / Period	3.8 kN/mm / 0.29s	9.0 kN/mm / 0.23s*
10 Damping	12% (snapback linear)	-

The tables above overview the house types and diagrammatically represent the wall configurations (lower level 1993 house) and the load systems used. The stiffnesses are based on quasi-static tests.

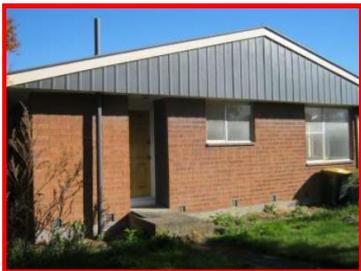
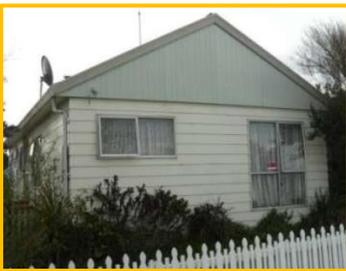
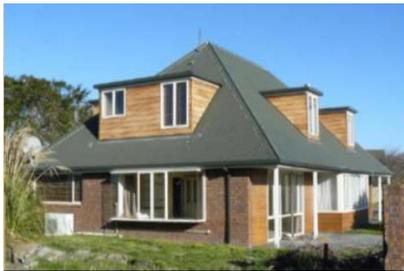
Table 1b. Houses Tested, Descriptions and Key Results

1970 - CARDRONA STREET	1983 - WAIROA STREET	1993 - NORCROSS STREET
1	Brick Veneer	Light fibre cement boards	Part brick veneer, part light fibre cement boards, solid brick garage boundary wall
2	Gypsum board linings	Gypsum board linings	Gypsum board linings
3	Suspended floorboards on piles	Suspended particle board on piles	Particle board on timber joist upper floor
4	Concrete piles, concrete perimeter foundation	Timber piles	Slab on grade lower floor
5	2013 - Hydraulic cyclic & snap-back	2012 - Diagonal unidirectional	2014 - Unidirectional & snap-back
6

8	1970 +	1983	1993
9	7.5-8kN/mm / 0.20s	18kN/mm / 0.14s*	27 kN/mm / 0.14s
10	>6% (10% by int walls)	-	2% ambient, ~6% hammer

The 1993 house had a very rigid garage wall with considerable torsion under load and had 11mm maximum displacement. Damping varied with deformation and was difficult to identify precisely and was therefore calculated using a hammer blow at lower storey eave level after the final 144kN load test was completed.
