A Tale of Two Earthquakes

Paul Grundy, Professor Emeritus
Department of Civil Engineering, Monash University
paul.grundy@eng.monash.edu.au

Abstract

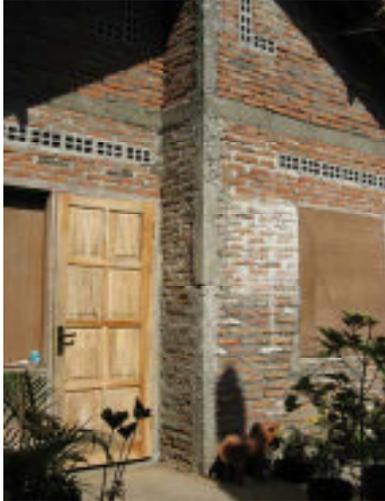
Figure 21: Typical RC framed brick construction

An even greater challenge than finding affordable earthquake resistant designs that could be built with minimal expertise imported from outside the community, was the achievement of adequate standards of construction. Figure 19 shows a house in preparation for reconstruction with RC framework; Figure 20 shows a completed brickwork and framing prior to rendering. However, Figures 21 and 22 show very poorly compacted concrete in the columns, which could largely undo the earthquake resistance of the structures.

Ideally, the concrete should be compacted with a mechanical vibrator. Such an item is too expensive for the individual house builder, but a community should be able to share or rent one, and to have a short training course in its proper use.

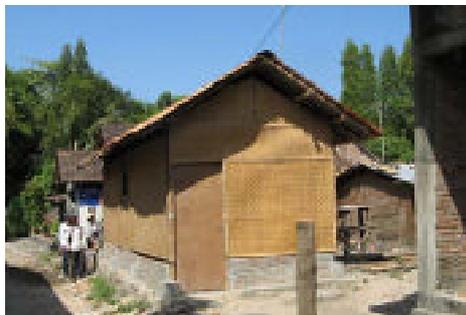
Woven grass screens were used for walls in some cases (Figure 23). These allow quick construction and are less dangerous in earthquakes, but they lack durability and provide less privacy. The frame is bamboo, which is good for earthquake resistance provided that there is adequate bracing to keep the roof in place.

Figure 23 – Bamboo framed house with grass mat walls

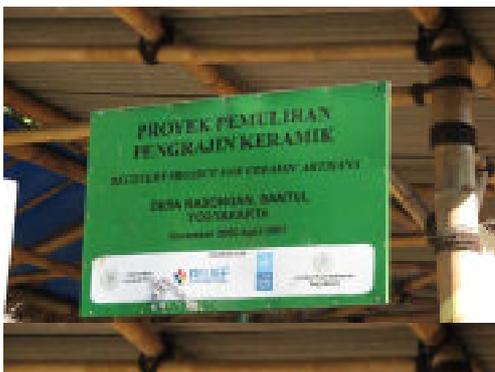
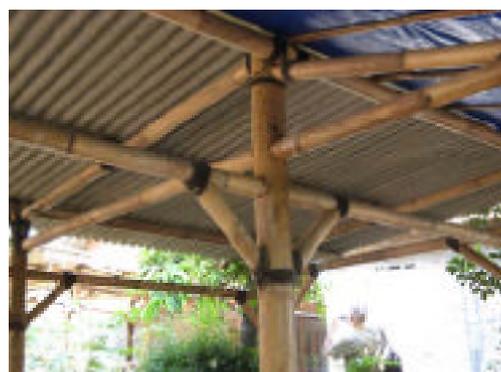
Bamboo framework has been adopted much more readily for commercial buildings, many of which in pottery and other crafts, are open sided. The bamboo frames are converted to portal action by means of struts lashed into the corners. (Figures 24 and 25.) Rather than heavy tiles lighter roofing material, asbestos cement sheeting one side and thatching on the other, are used. The life of the binding rope is variously estimated, typically 30-40 years. The bamboo requires soaking for a month as part of the preparation. Chemicals can shorten this period.

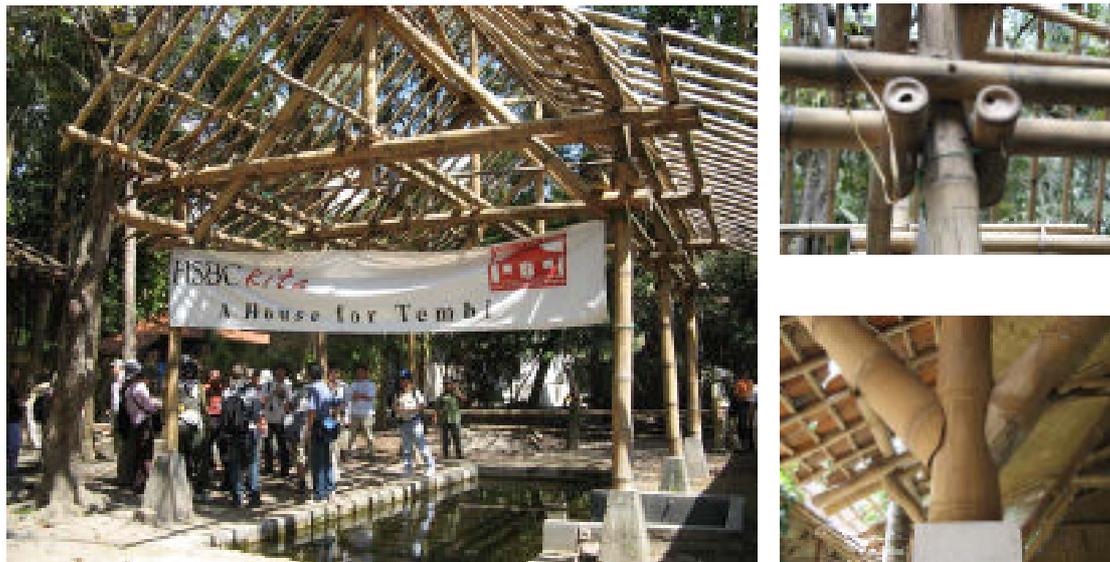
Some frames used connections incorporating a single long bolt (Figure 26). These buildings recycled the roof tiles from the buildings which fell in the earthquake.

Figure 26 – Bamboo framed craft centre with long bolted connections
