IMPACTS OF REMOTE LOW LEVEL SEISMIC EVENTS ON THE MONARO REGION NSW

Australian Earthquake Engineering Society Conference,
18-20 November 2011, Novotel Barossa Valley Resort, South Australia

Geoff Bowland

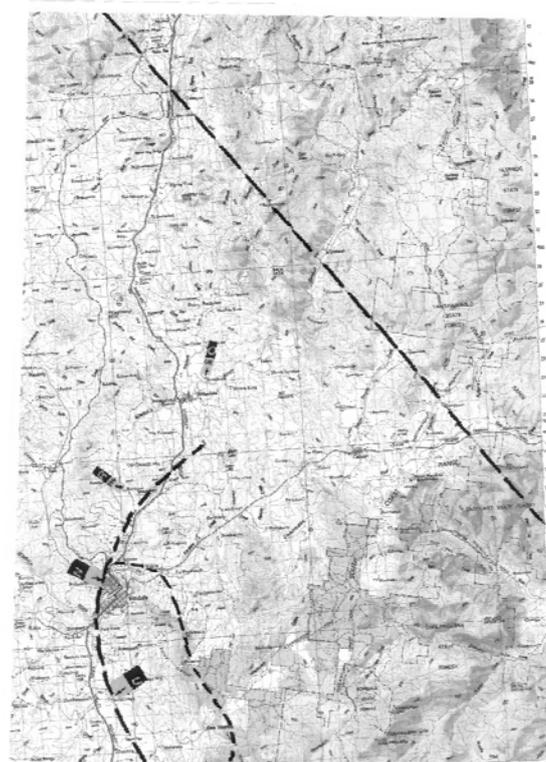
Bombala fault lines
Fig 4

writes from Currawong etc. with a similar story. Currawong is located about two kilometres north of the church on the same fault line and Burnamah is about five kilometres north near the same line. The following log of events shows 150 years of regular seismic activity in the Bombala area. By the law of averages a bigger event should be expected and alertness and preparedness are warranted.
