Performance Study of Seismic Bracing Assemblies of Suspended Ceiling Systems

G.C. Yao & W.C. Chen

Department of Architecture, National Cheng Kung University, Taiwan.

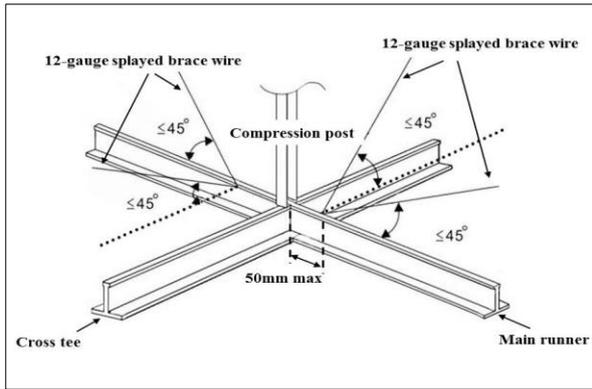
Figure 1. Details for the bracing assembly

In 2011, an appendix referring to ASTM E580-06 was issued in the Taiwanese building seismic design code. The appendix explicitly provides guidance for the seismic installation of the suspended ceiling systems. The main construction details include the use of the fixtures at two fixed adjacent ends and the installation of the edge hanger wires which have proven advantageous in limiting the movement of the ceiling systems. In addition, the lateral bracing assemblies are required for all ceiling areas greater than 100m². However, the construction of the bracing assembly has always been a difficult problem leading to uneven qualities of the suspended ceilings. Figure 1 shows a bracing assembly consisting of four wires splayed 90° from each other also at an angle not exceeding 45° from the ceiling plane and a vertical strut performing as a compression post. To satisfy the demand of the angle not exceeding 45°, sufficient space in the horizontal direction is necessary. However, the installation of the suspended ceilings has always been arranged after the construction of other overhead non-structural elements such as mechanical equipment and piping systems. For this reason, the lateral bracing members especially the splayed wires are frequently obstructed by equipment and consequently installed in bad construction. Figure 2 demonstrates a common situation of ceiling construction in Taiwan, and it is obvious that there is almost not enough space to set up the bracing assembly.

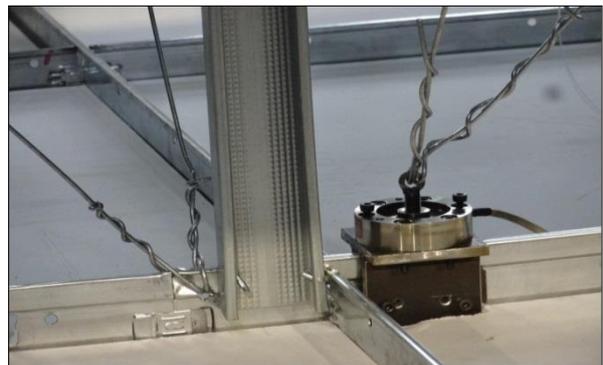
Figure 7. Installation of the load cell

smaller than 100m². The lateral bracing assemblies were placed 1840mm from the boundary and the distance between two bracing assemblies was 3660mm. Moreover, the bracing assemblies were installed only in the A type configurations since the spacing regulations mentioned above were not applicable in the B type configurations. In order to determine the effect of the bracing assembly, a load cell was installed on splayed wires as shown in Figure 7.

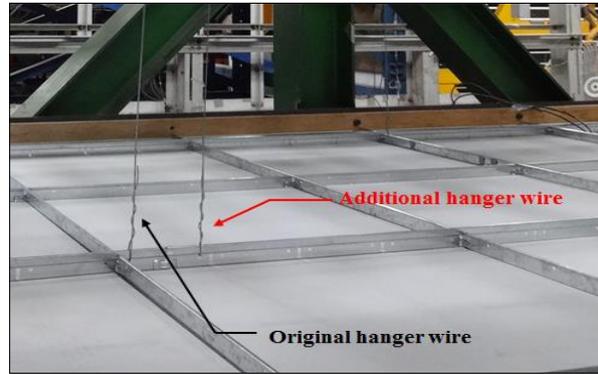
Figure 8. Detachment of the main runner joint Figure 9. Installation of the additional hanger wire

Table 1 summarizes the ceiling configurations. The ceiling specimens are divided into three groups in accordance with the installation of the bracing assemblies while all other details are identical. One thing is particularly worth mentioning, a certain connection joint of the main runner in the A type detached (Figure 8) every time when excited by vertical excitations, and this unexpected failure happened not only in one specimen. Therefore, an additional hanger wire shown in Figure 9 (denoted as “Connection joint reinforced” in Table 1) was installed when the specimen was reconstructed. The reason of this problem will be further discussed in the following section.

The damage to the connection joint of the main runner is an unexpected failure during experiments. The 7.3m main runner of the A type consisting of three pieces of grid members and has two connection joints along the grids, one of the joints shown in Figure 16-a failed frequently at low amplitude vertical excitation. Studying the locations of these two connection joints, the damaged joint is placed closely beside a hanger wire while the undamaged one is placed at the middle of two hanger wires (Figure 16-b). Displacement incompatibility on both sides of the connection joint is considered the most possible reason of the failure condition. When the grid members sustain downward loading inclusive of the excitation and the impact force from tiles, the grid on the left side of the joint is directly restrained by the hanger wire but the grid on the right side vibrates obviously. To prevent the displacement incompatibility between the connection joints, an additional hanger wire is installed

beside the joint as shown in Figure 16-c, which has proven effective since no failure is observed after reinforcing.

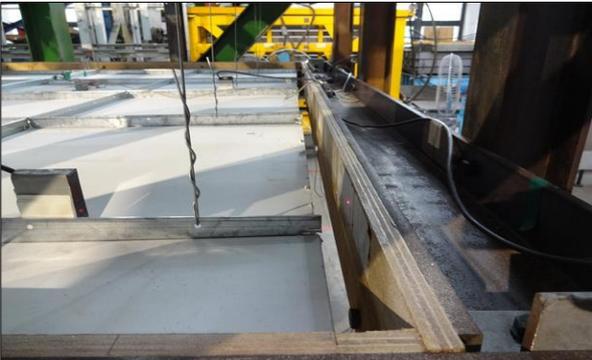
Figure 14. Specimen without wall moldings

The primary damage in perimeter connections is the unseating of the ceiling grids from the wall molding as shown in Figure 12. Since 50mm wall molding is barely used in Taiwan therefore only 24mm wall molding was applied in the experiments. This failure can possibly due to the insufficient seat length of the wall molding at the unfixed sides or the failure of pop rivet at the fixed sides. As the unseating grid members move back toward the perimeter boundary, the grids hit the wall molding to cause the observed damage (Figure13). In some cases the failure of perimeter connection result in grid members and tiles falling from the ceiling, which particularly occurred around the connections of cross tees and wall moldings. In this paper, an additional test (B type configuration) without the wall moldings was conducted to evaluate the performance of the ceiling in a severe condition. The grid members of the ceiling were still intact in the shape of rectangle after the test and no falling tiles were observed (Figure 14). The result demonstrates the edge hanger wires can effectively prevent the grid members and tiles from falling.

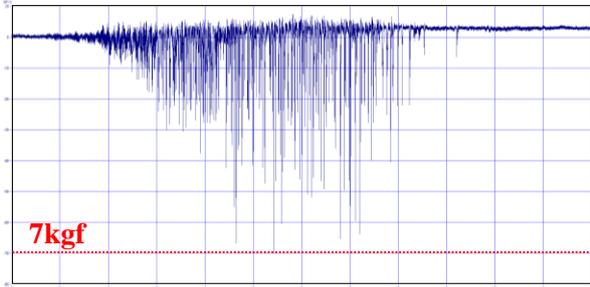
Figure 17. Tensile force of the splayed wire

This paper aims at evaluating the seismic capacity of the lateral bracing assembly, and the experiment results demonstrate that both braced and unbraced ceiling system perform well when undergoing horizontal motions. During the experiment C5, the maximum horizontal acceleration is approximately 2.0g and generates 420kgf of the horizontal inertial force as the self-weight of the ceiling system is about 210kgf. The load cell installed on the ceiling specimen help to measure the tensile force of the splayed wire and the maximum value is 7kgf (Figure 17). The result shows the bracing wire only sustains 3% of the horizontal inertial force.

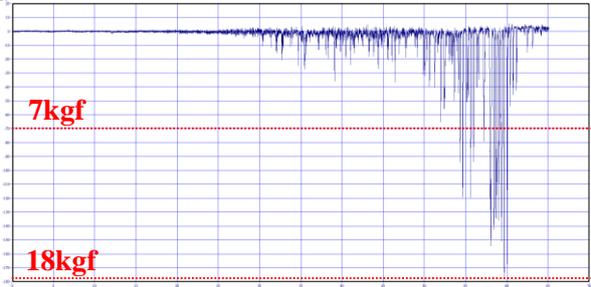
Figure 18. Tensile force of the splayed wire

In the first stage of the experiment C6 (H1300, V300), the tensile force sustained by bracing wire is lower than 7kgf as the vertical excitation is applied to the ceiling,. This is because that the bracing wire buckled easily when suffering upward excitation and therefore loses its resistance to the lateral force. This observation points to an important message; that is, the installation of the lateral bracing assembly may not improve the seismic response of the ceiling system especially if the system is subjected to vertical excitation. Damage to perimeter connections occurred in the sequent stages of experiment C6 and it makes the ceiling become a system without edge retrainers. In comparison with the result of C5, the splayed wire of C6 sustained more tensile force. However, the maximum tensile force measured before the ceiling collapsed is 18kgf (Figure 18), which indicates that the bracing wire still sustains less than 10% of the horizontal inertial force. The ineffectiveness of the bracing wire is considered mainly a result from the slack wire effect. Although the wire is installed tightly before the tests, it becomes slacker as experiments progressed. Therefore, the slack wire allows some lateral movement before it effectively restrains the ceiling. However, the clearance is only 12mm between the ceiling grid and the boundary, which makes the wire difficult to perform ideally before the ceiling impact the boundary.
