What Can Australia Learn From Christchurch?

H.J. Hare

Holmes Consulting Group

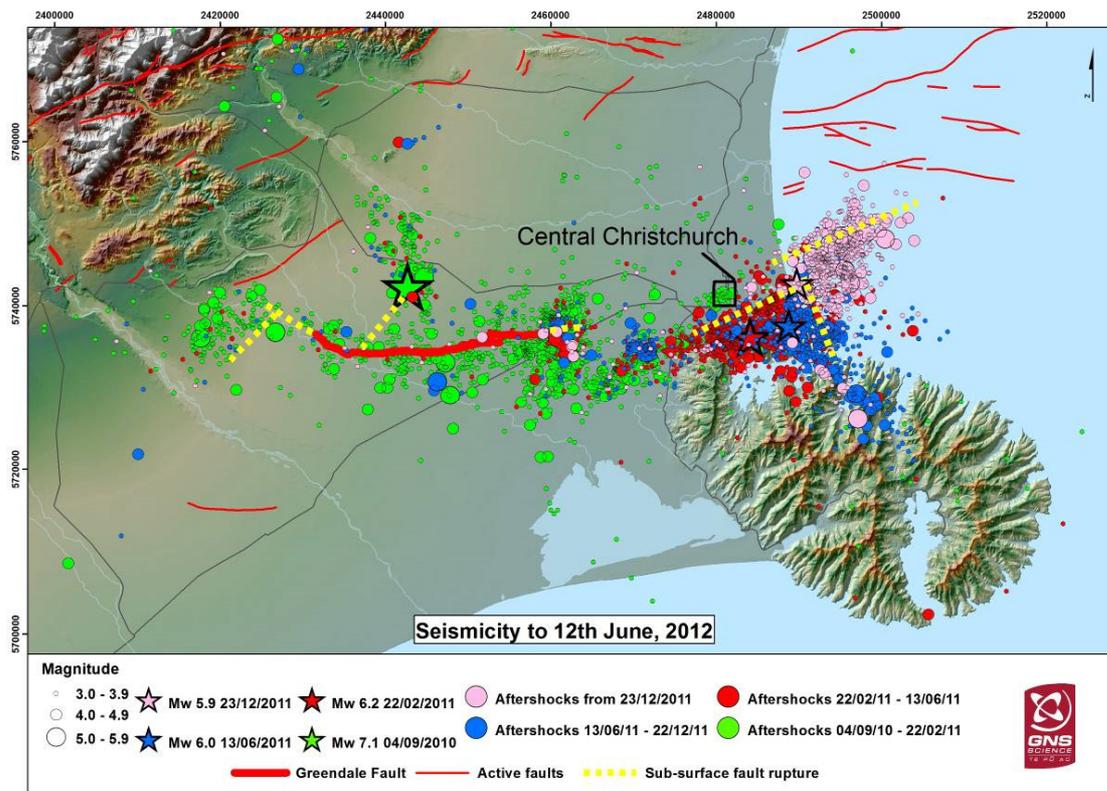
Figure 1. Earthquakes recorded to June 12th 2012 (from GNS Science)

The first of the Canterbury earthquakes (the Darfield earthquake) struck at 4:35am on September 4th, 2010. Centred near Darfield, approximately 40km to the west of Christchurch, the M7.1 earthquake caused moderate levels of damage in the city. The epicentre is marked by the green star in Figure 1 below. Maximum shaking intensity of MM9 was observed, but the most severe shaking was in less populated areas.

In total at time of writing, there have been over 10,000 earthquakes in the series. Of these, 52 have been of M5 or greater, with extensive damage at varying levels spread over the five major events, notably on June 13th, 2011 (the blue star), and December 23rd, 2011 (the pink star). Although not as severe in the central city as the Feb 22nd event, the June 13th events in particular caused further damage to the east of the city, including severe rockfall in the seaside suburbs of Redcliffs and Sumner, and still more liquefaction. Figure 1 illustrates the overall spread of the events, with reference to the major events.
